# Lower Cypress Creek Pilot Project: Assessment of *E. coli* Bacteria and Optical Brighteners

Cypress Creek Stakeholder Committee Meeting

December 15, 2022

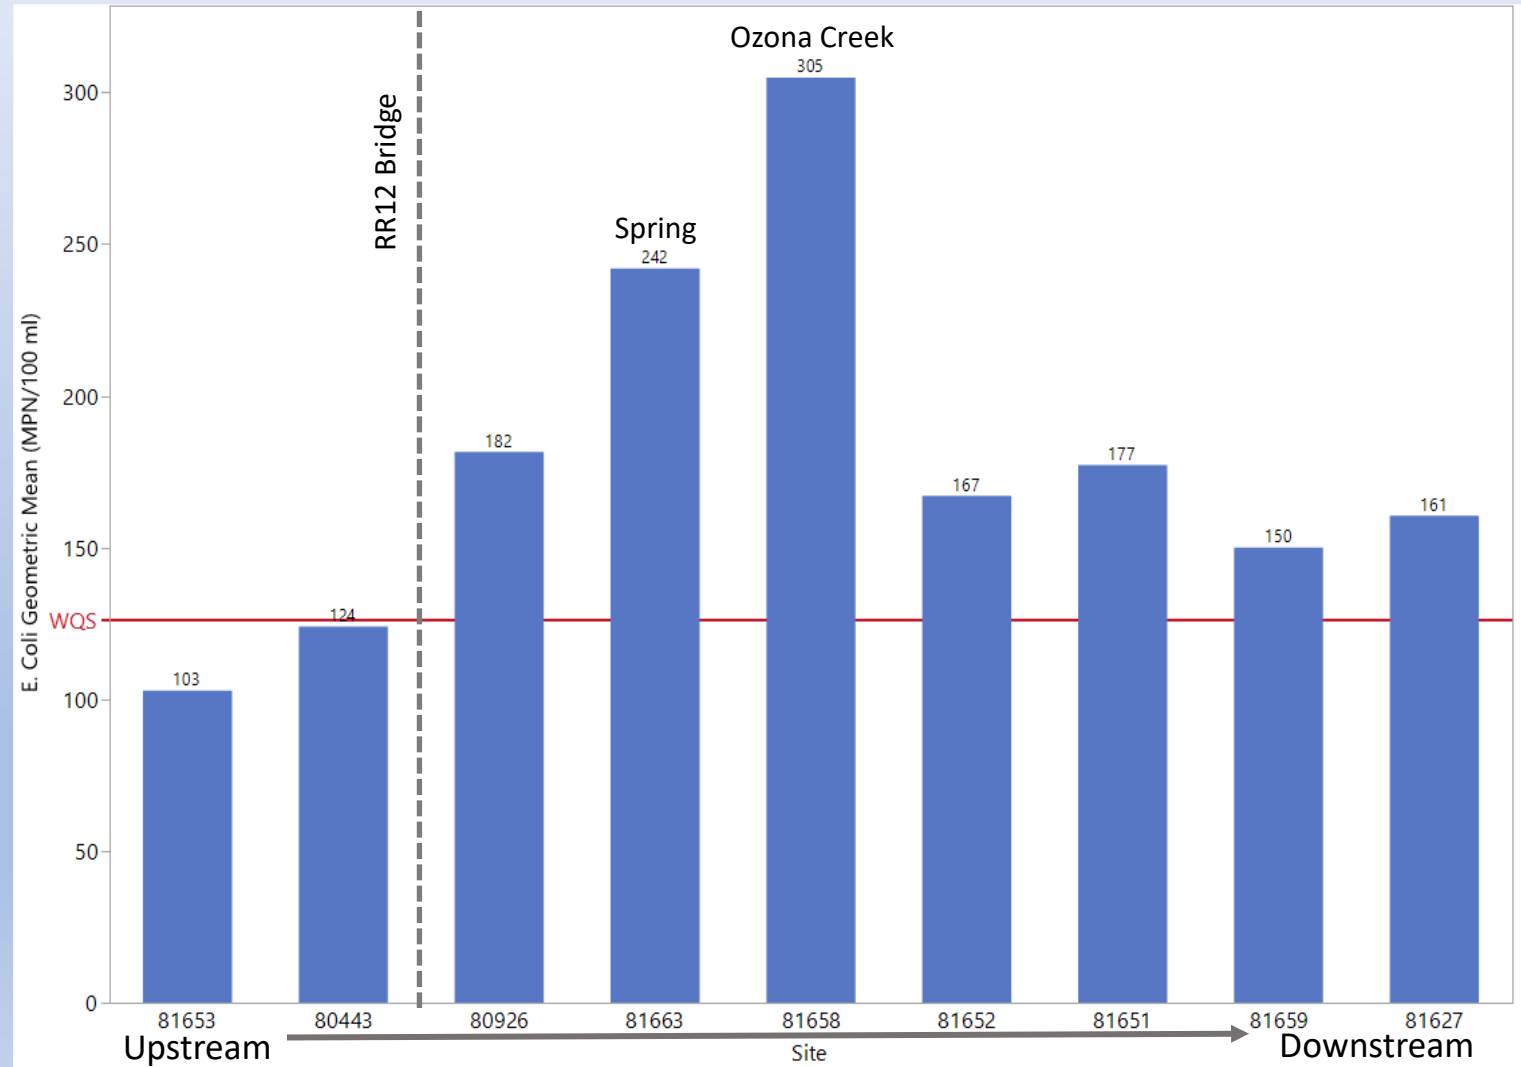
Site	N	E. Coli (MPN/100 ml) Geo Mean
81653 – upstream	62	103
80443 – upstream	62	124
80926 – midstream	62	<b>182</b>
81663 –Spring	5	<b>242</b>
81658 – Ozona Creek	40	<b>305</b>
81652– midstream	61	<b>167</b>
81651– midstream	63	<b>177</b>
81659– downstream	50	<b>150</b>
81627– downstream	62	<b>161</b>

Bacteria geometric means were:

- Higher downstream of RR12 bridge than upstream
- Highest at 81658 – Ozona Creek
- Lowest at 81653 – most upstream site

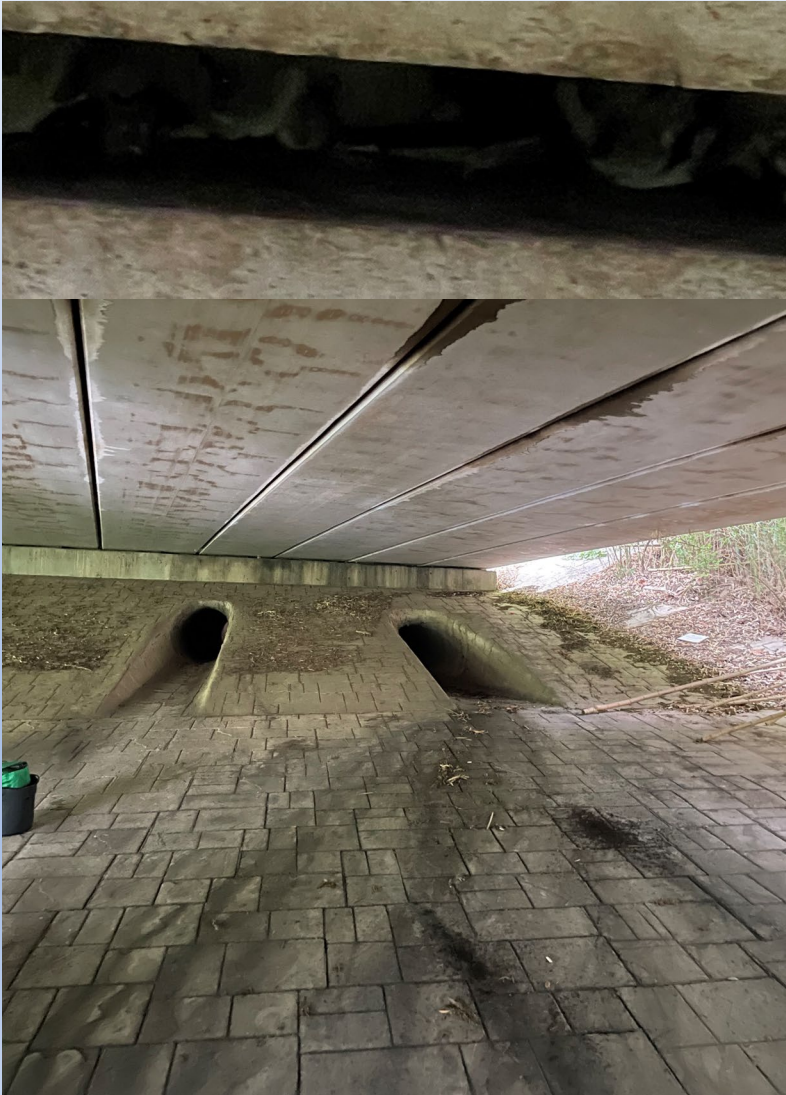
# Temporal Effect of Bat Colony

- E. coli geometric mean for site 80926 – below RR12 bridge
- Bats migrate away from area from about November to March

- Fluctuated monthly – highest in October 2022, lowest in March 2022
- Values correspond to bat migration and precipitation
