Cypress Creek Project Watershed Characterization Report

CYPRESS CREEK WATERSHED PROTECTION PLAN

Characterization Report

**The River Systems Institute
Texas State University-San Marcos**

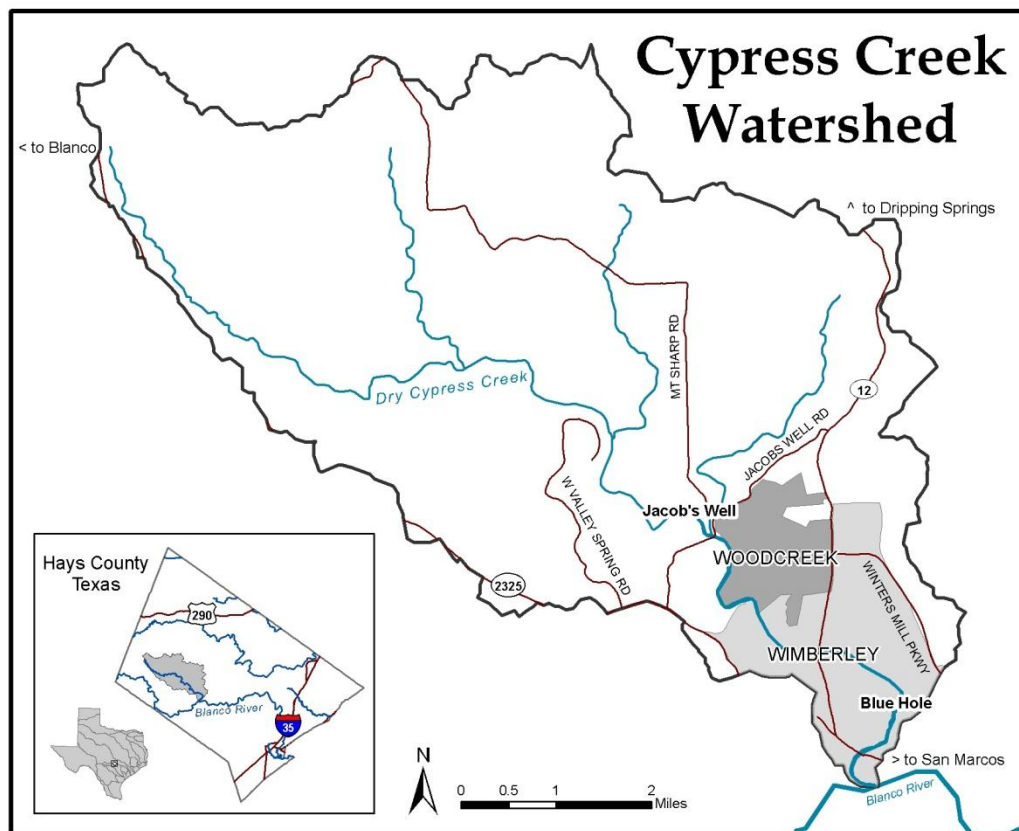
Figure 1.1 Cypress Creek watershed, central Texas.

The Cypress Creek watershed is home to a unique set of rural and urban communities, ecosystems, and a long-standing reliance on groundwater for both drinking supply and recreational uses. A detailed discussion of the geography and physical setting of the watershed is given in Section 2.0. Cypress Creek flows through unincorporated portions of Hays County and the cities of Wimberley and Woodcreek. It meets the Blanco River near the Wimberley town center (Figure 1.1).

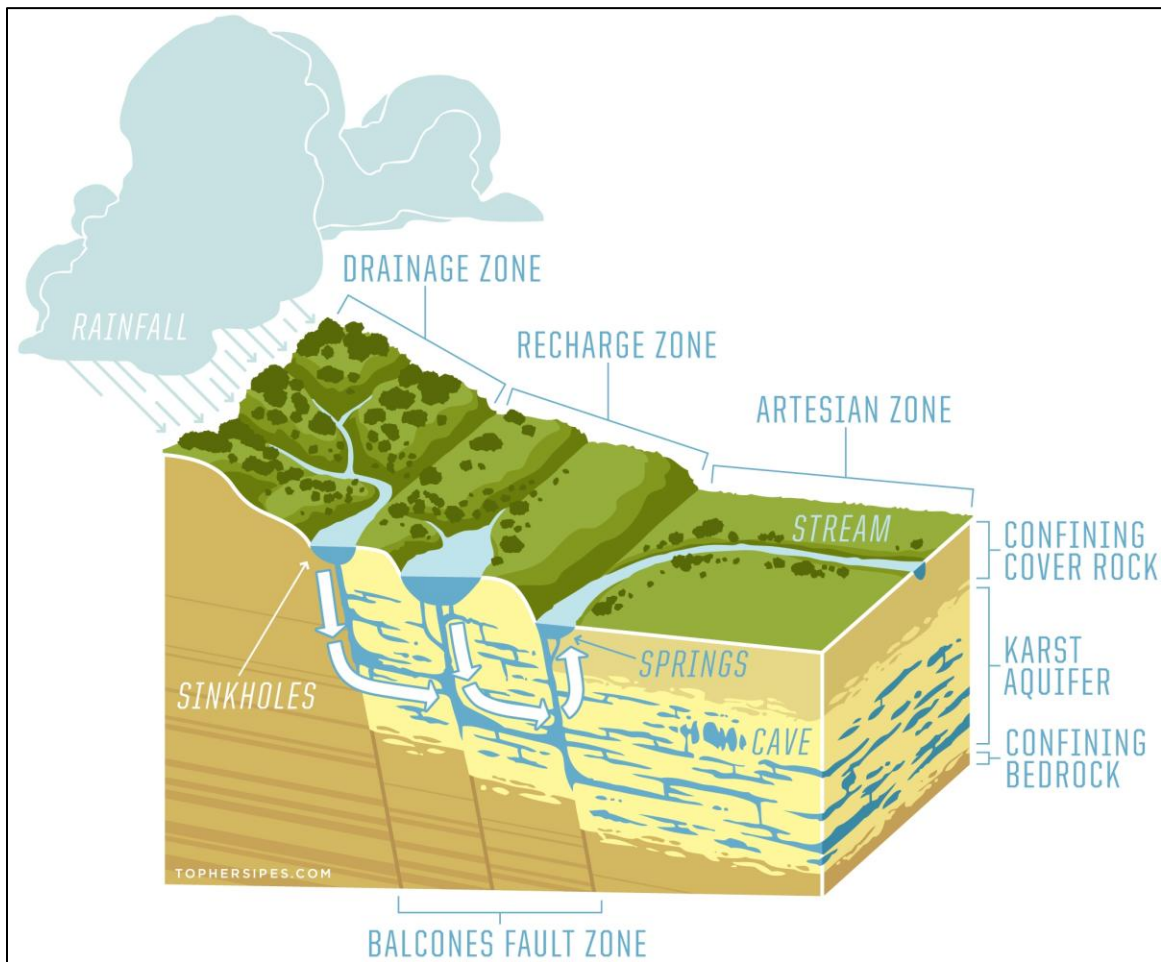
Figure 1.2. Diagram of surface water recharge to groundwater. Courtesy of Topher Sipes.

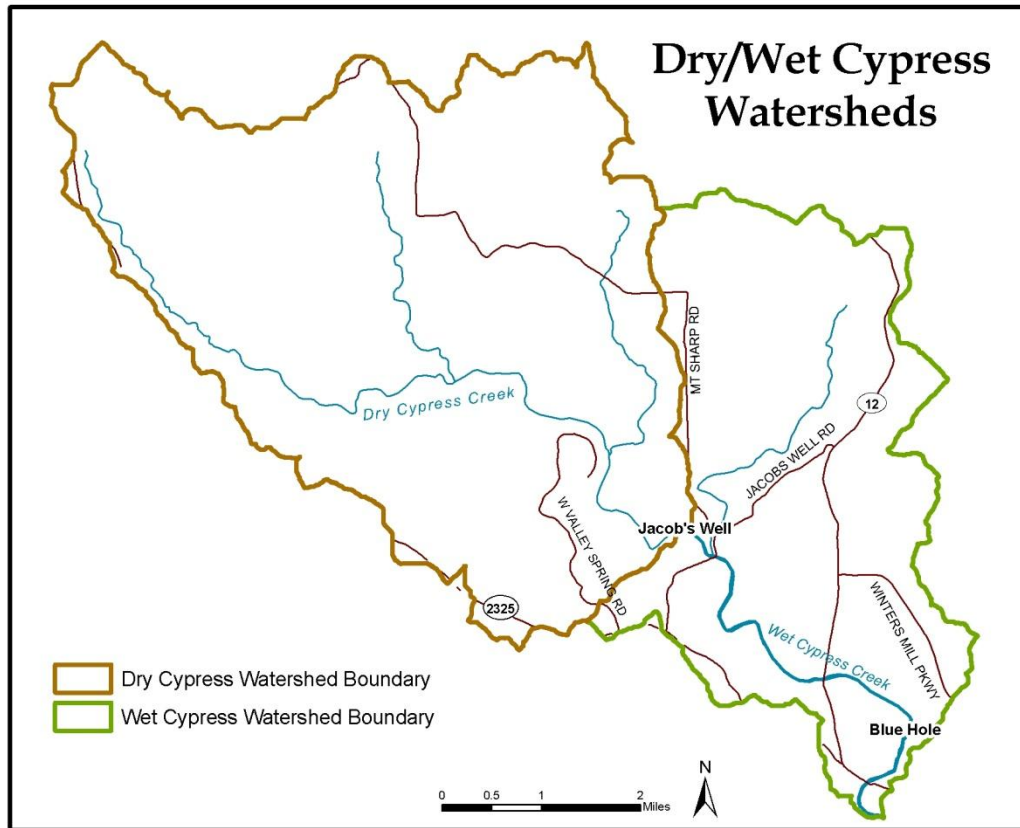
Figure 2.1. Dry and flowing segments of Cypress Creek.

Based on historic streamflows, Cypress Creek can be subdivided into dry and flowing segments (HTGCD, 2008). Unless a major rainfall takes place, the 9.5-mile segment above Jacob’s Well is usually dry (Figure 2.1). The spring at Jacob’s Well augments creek flows during the year for the downstream, 5.5-mile long stream segment trending southeast of Jacob’s Well. The downstream segment is referred to as Cypress Creek. The stream gradient of the lower part of the creek is calculated at 21.4 feet per mile.

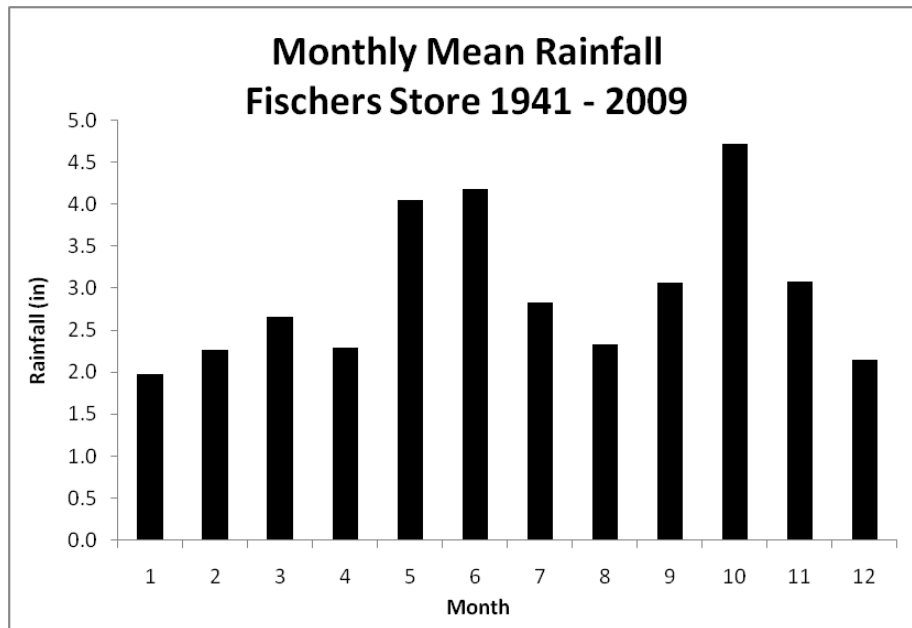
Figure 2.2. Monthly mean rainfall at Fischer's Store (1941 – 2009).

Climate in the study area follows the general pattern of the Hill Country; peak rainfall tends to occur in the summer and fall. For example, at the Fischer's Store gauge that is located about 6 miles (9.6 km) west-southwest of the watershed, 23% of annual rainfall occurs between May and June, while 30% occurs between September and November (Figure 2.2).

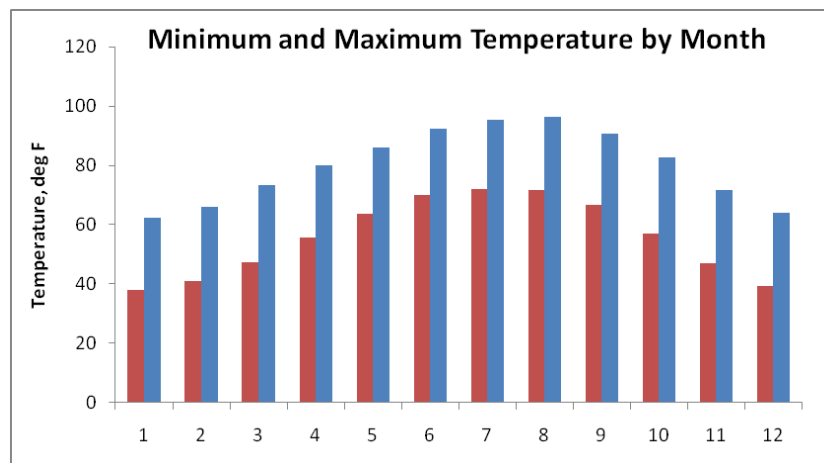
Figure 2.3. Monthly temperature ranges in Cypress Creek watershed.

Temperature in the area is highest from May through October, resulting in fairly predictable summer weather patterns (Figure 2.3). The period of July through September is often both hot and dry, with average daily temperatures above 80°F (26.67 °C) and little rainfall. Since water quality in the Cypress Creek is highly dependent upon flow, summer months are the most likely to have water quality impairments in the creek including low dissolved oxygen, high algal density, and increased water temperature.

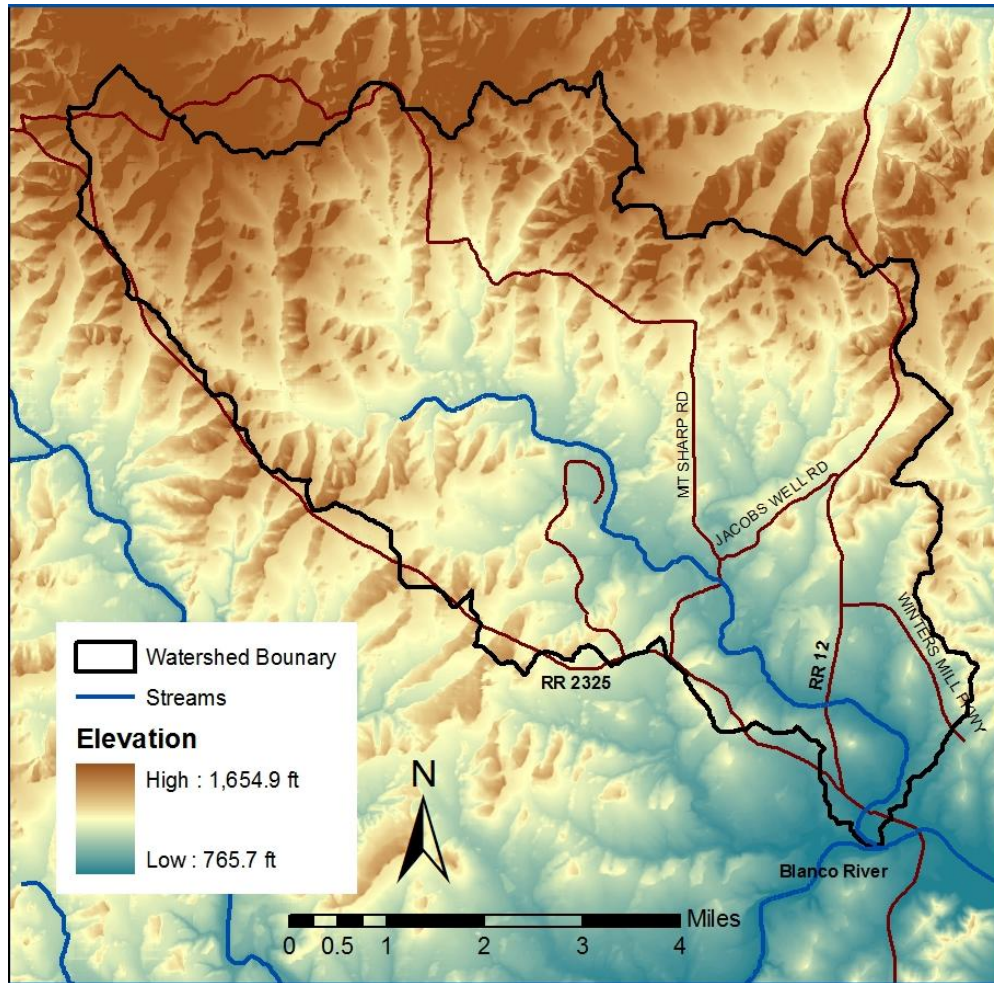
Figure 2.4. Watershed topography.

Slopes are higher in the northern portion of the watershed, where there are many of the characteristic hills that make up the Hill Country region, and slope generally decreases toward the City of Wimberley near the outlet of the watershed (Figure 2.4). Urban development has thus far been concentrated in the lower third of the watershed around Woodcreek and the City of Wimberley. Therefore the highest risk for excess sediment flow in the creek due to high slope comes from agriculture (primarily grazing) activities in the upper and northern portions of the watershed, and in bottomland areas the primary threat for excess sediment flow results from development activities and land clearing. Numerous cliffs and deep valleys typify the topography of the watershed. Elevations range between 812 and 1,571 ft (247 to 479 m) above mean sea level. Approximately 759 feet (231.5 m) of topographic relief is found across the study area.

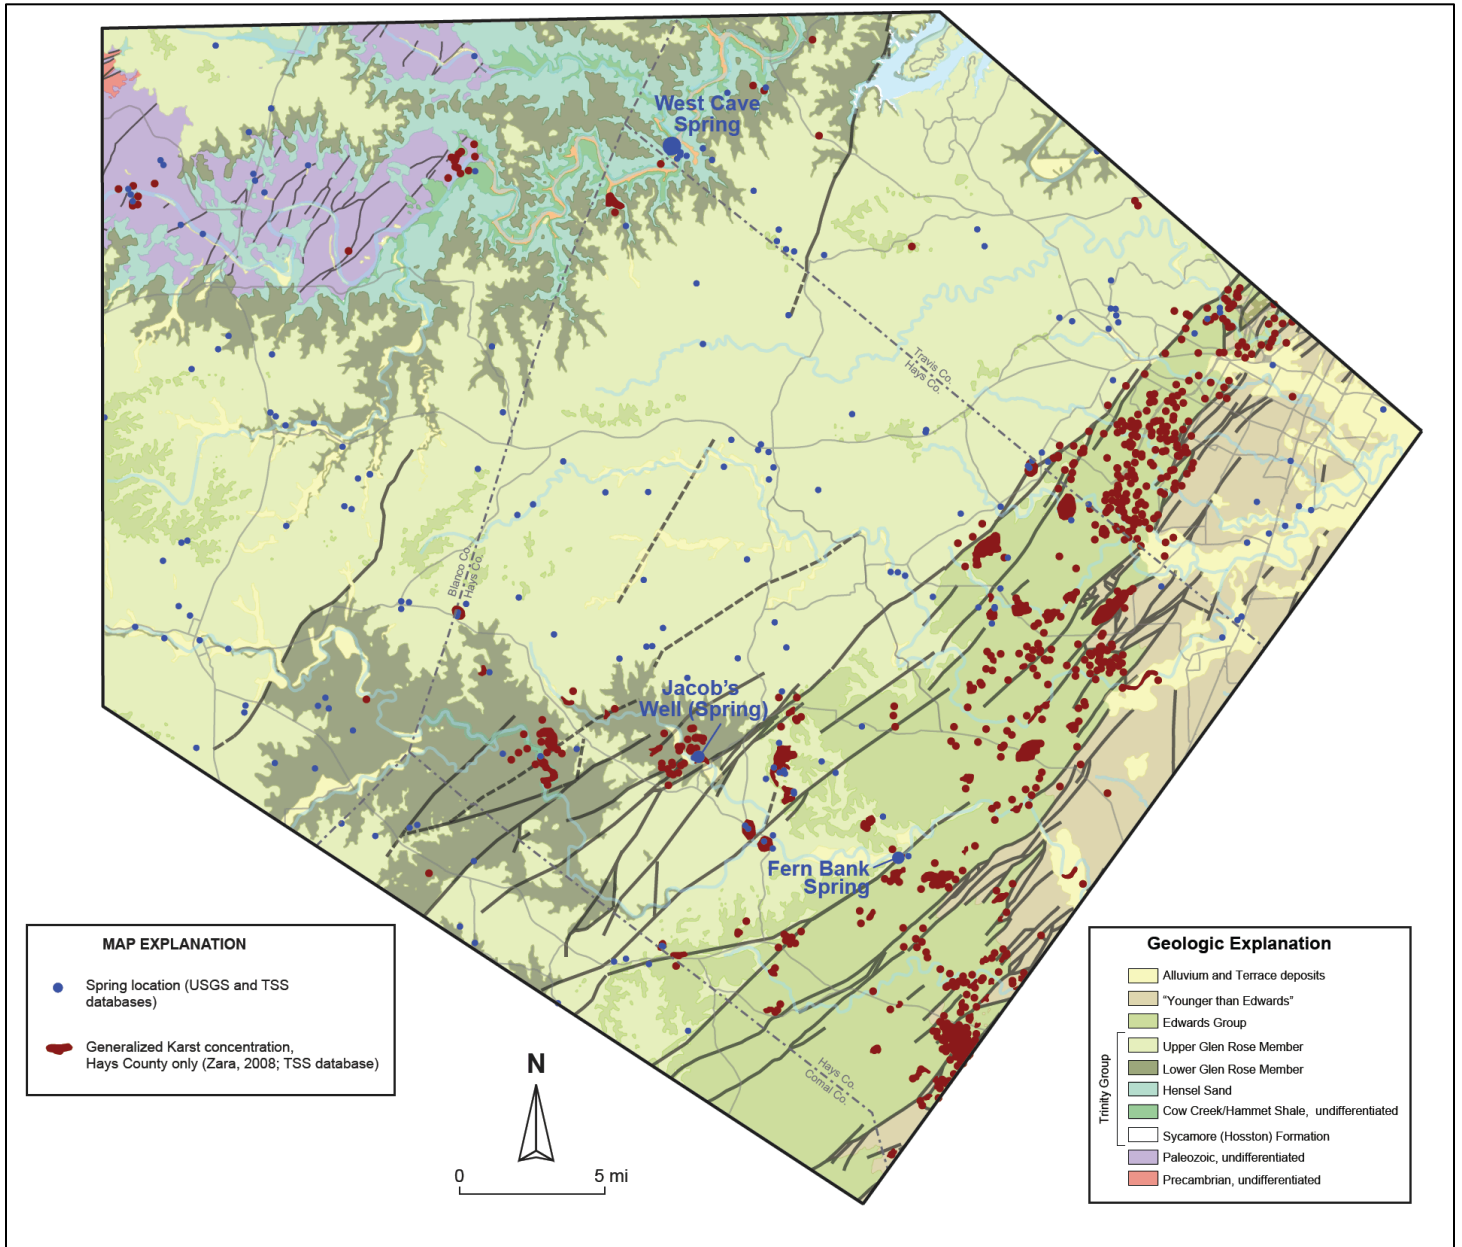
Figure 2.5. Generalized karst features, courtesy of HTGCD.

In the Cypress Creek watershed as in much of the Hill Country, karstic features are found throughout the landscape (Figure 2.5). Rounded limestone hills, cliffs and narrow valleys, springs and seeps are all part of this landform. Rock layers that alternate between easily eroded and hard rock form jagged cliff profiles and overhangs. The exposed limestone formation along Cypress Creek is a key karst feature that supports groundwater recharge to the underlying aquifer (HTGCD, 2008).

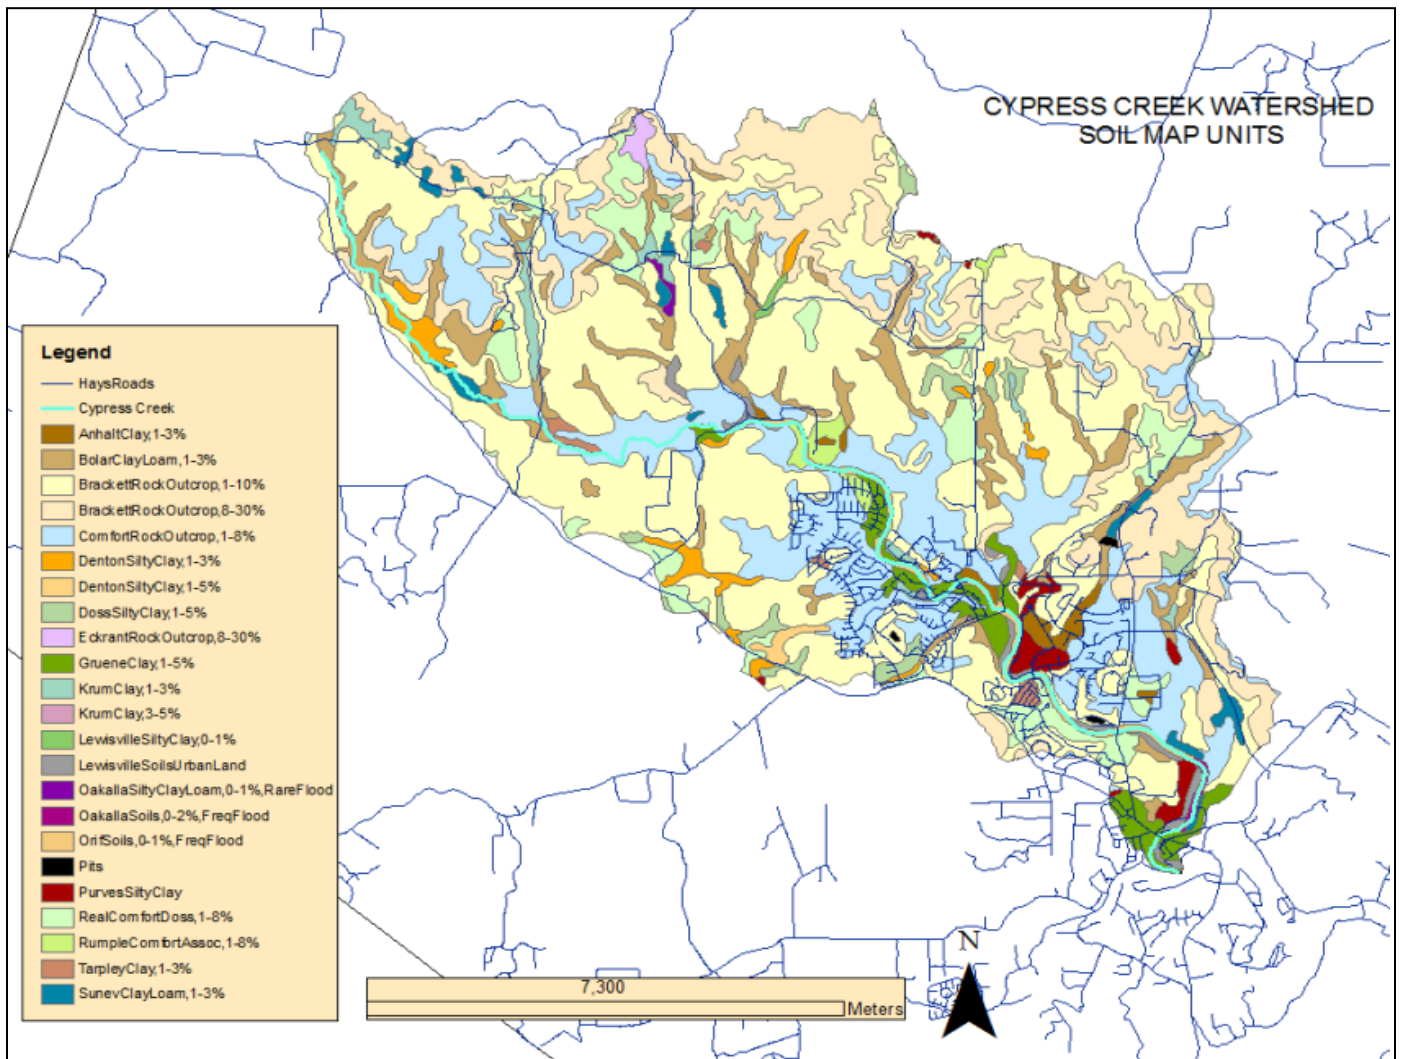
Figure 2.6. Soil units in the watershed.

Soils in the watershed are predominantly shallow clay loams and shallow clays such as the Brackett-Rock outcrop-Comfort complex (41.5%) and the Brackett-Rock outcrop-Real complex (15.3%) on the uplands; and shallow stony clays such as the Comfort-Rock outcrop complex (17.9%) and the Real-Comfort-Doss complex (5.6%) on hill slopes. The remaining 20 % of the watershed is a mix of deep clay and clay loam uplands and hydric loamy bottomland soils along creek beds in the lower portion of the watershed (Figure 2.6). Table 1 gives the types and relative area of soils present in the watershed. Soil classes are based on the Natural Resources Conservation Service (NRCS) soil survey geographic database (NRCS, 2008).

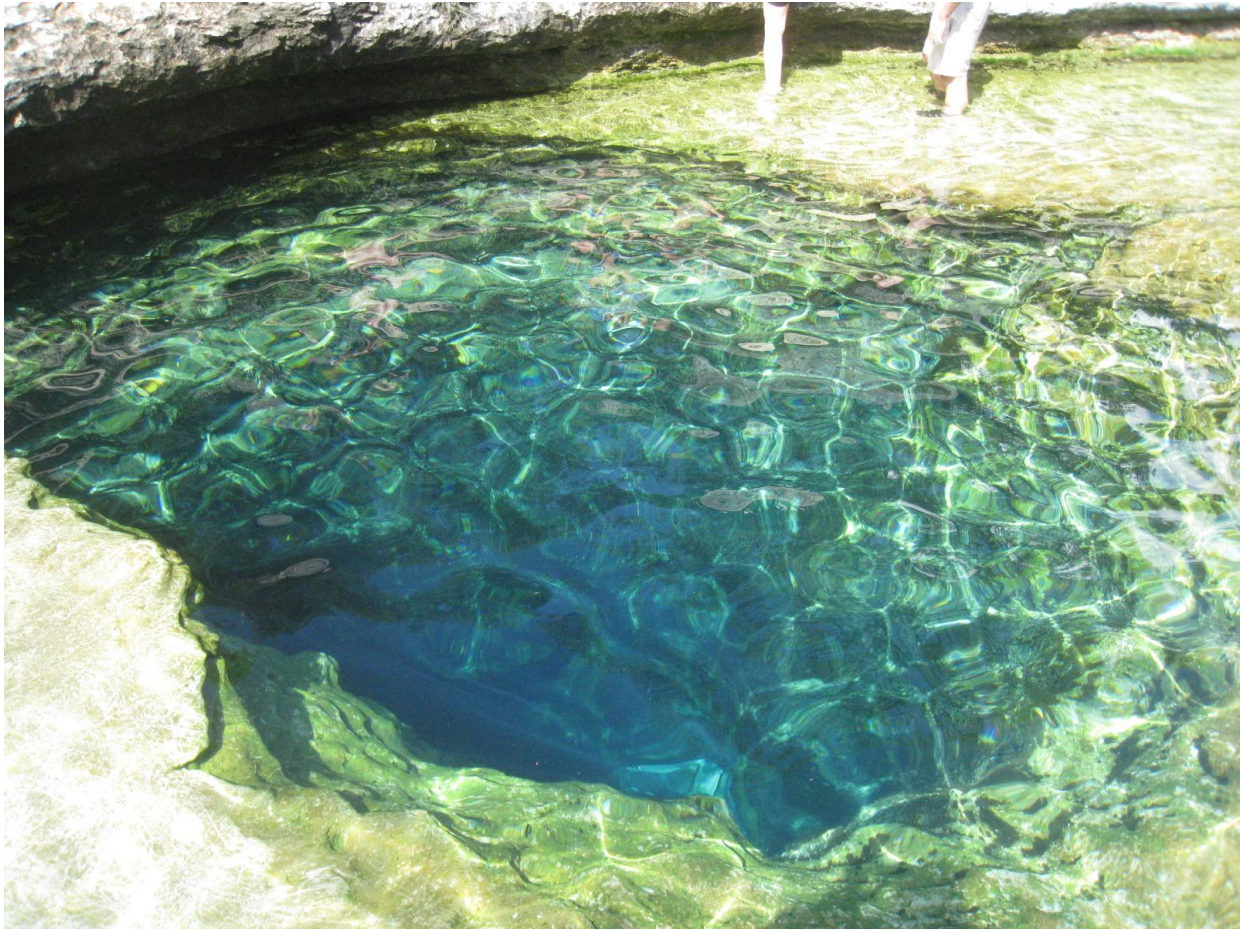
Figure 2.7. Jacob's Well. Photo by Vanessa Lavender.

The opening of Jacob's Well (Figure 2.7) in the bed of Cypress Creek occurs in the Lower Glen Rose unit of the Middle Trinity Aquifer. The nearly vertical shaft of Jacob's Well probably follows a former fracture or joint set that has been enlarged by solution activity. Approximately 70 feet below the mouth of the spring is the contact between the Lower Glen Rose and Hensel Member. There are two large caverns at the contact. At 100 feet is the contact between the Hensel and Cow Creek. The passageway becomes roughly parallel to the horizontal bedding and continues several thousand feet in a karst zone of the Cow Creek.

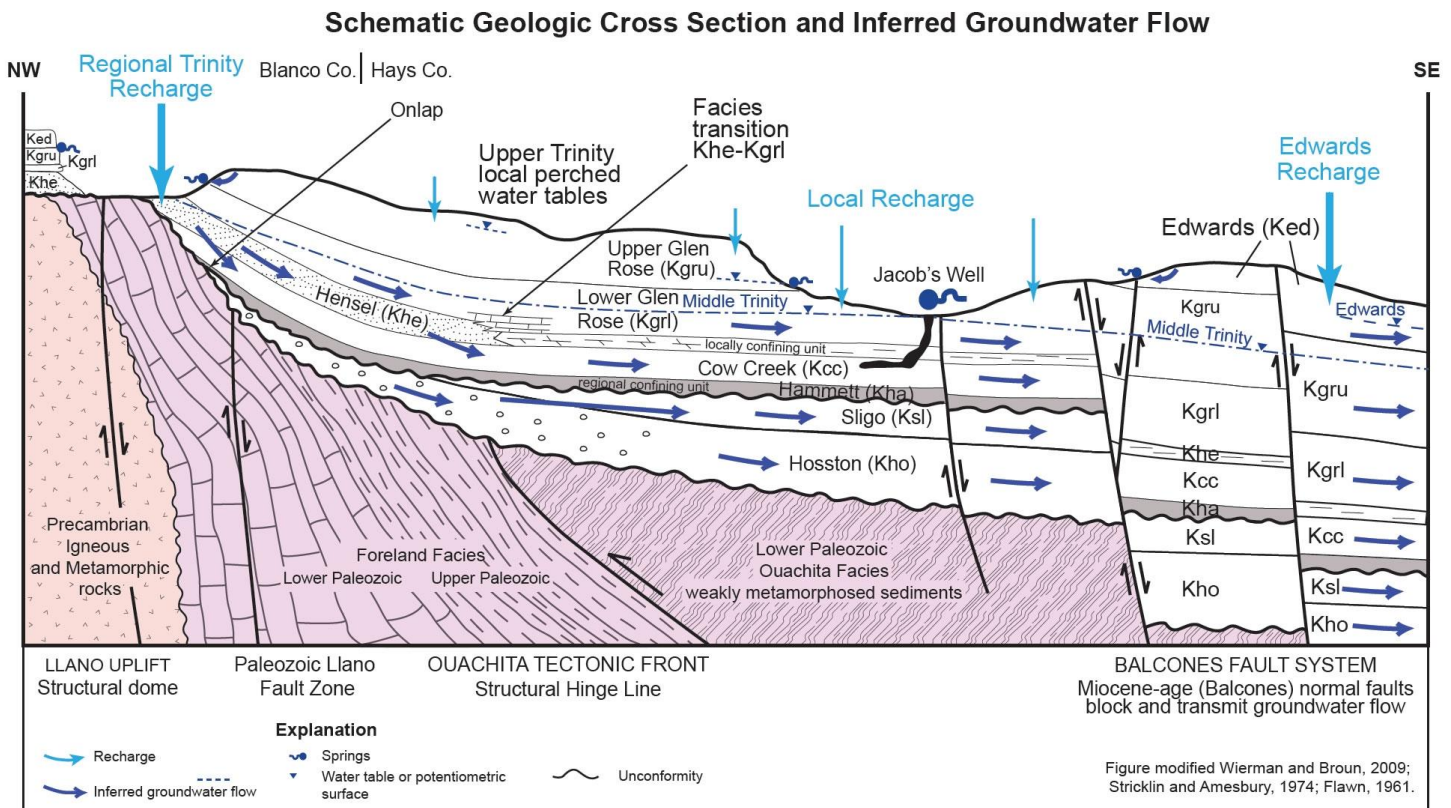
Figure 2.8. General Stratigraphy and Movement of Groundwater of the Trinity Group. Courtesy of HTGCD, 2010.

(Figure 2.8). At the current time divers have mapped in excess of 5,000 feet of passages linked to Jacob’s Well. Several passages terminate in constrictions that divers cannot proceed beyond; others are still in the process of being fully explored.

Baseflow to Jacob’s Well is artesian flow from the Cow Creek up through the confining Hensel and Lower Glen Rose. The major source of recharge to the Cow Creek occurs west of the Cypress Creek watershed from the downward leakage of water from the Upper and Lower Glen Rose and Hensel where these formations are exposed at the surface and exposed to precipitation. Water moves downward into the Cow Creek and down dip towards the Balcones Fault Zone (BFZ) to the east. As the overlying Hensel changes facies from a sand to a calcarenite/dolomite facies, it tends to act as a confining layer creating artesian conditions in the Cow Creek. The faults of the BFZ (Tom Creek Fault Zone) tend to restrict the horizontal movement of groundwater forcing groundwater upward with surface discharge via Jacob’s Well. Groundwater under artesian conditions in the Cow Creek provides the majority, if not all of the base flow at Jacob’s Well.

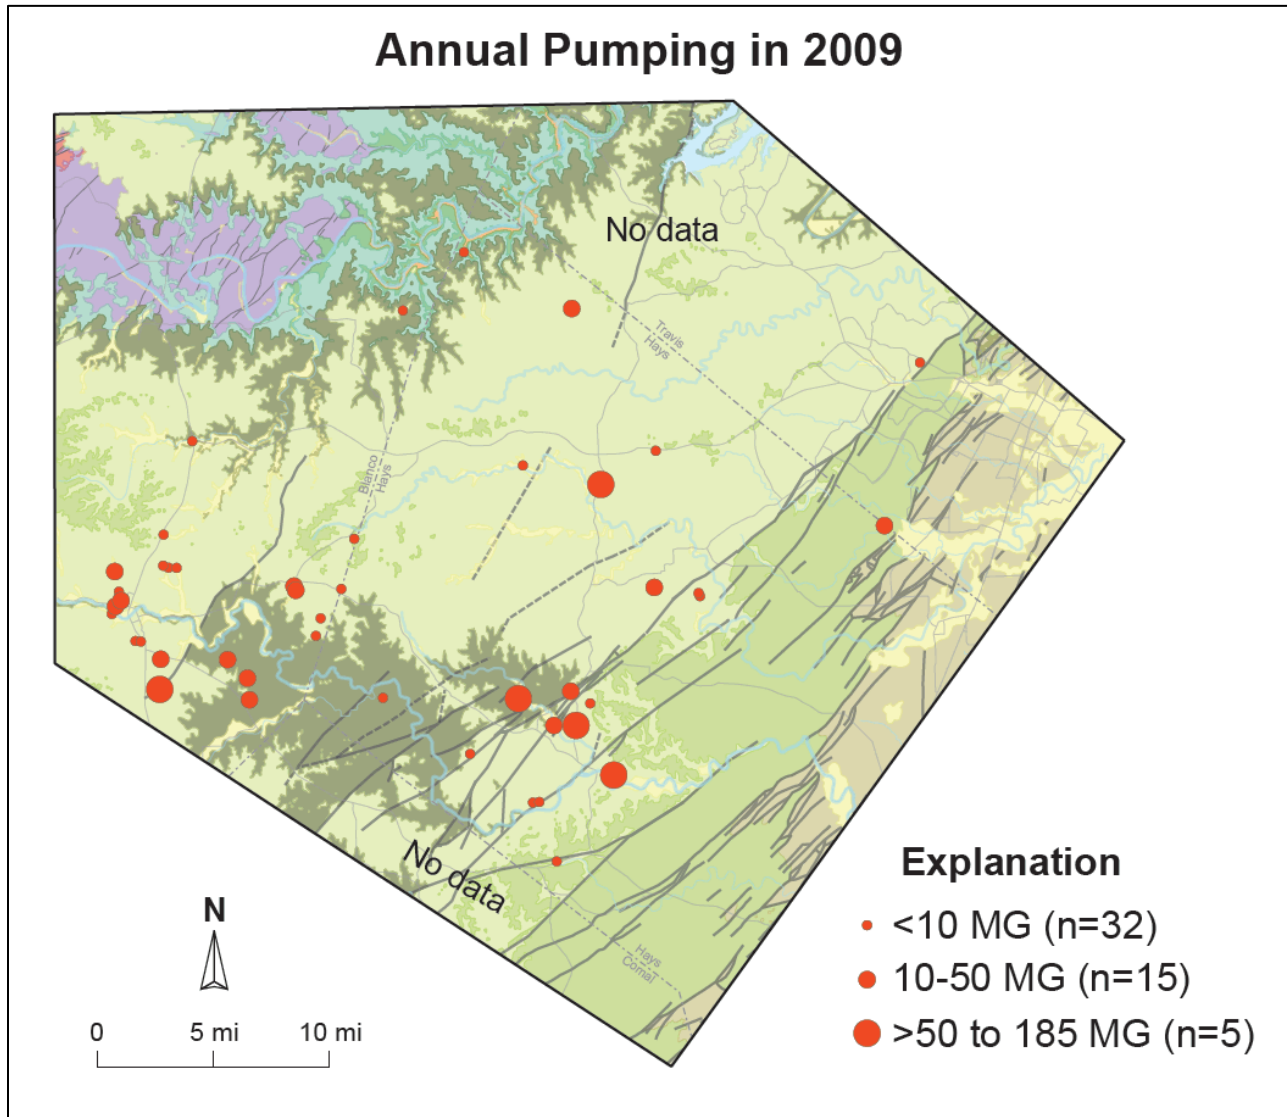
Figure 2.9. Groundwater pumping. Courtesy of HTGCD.

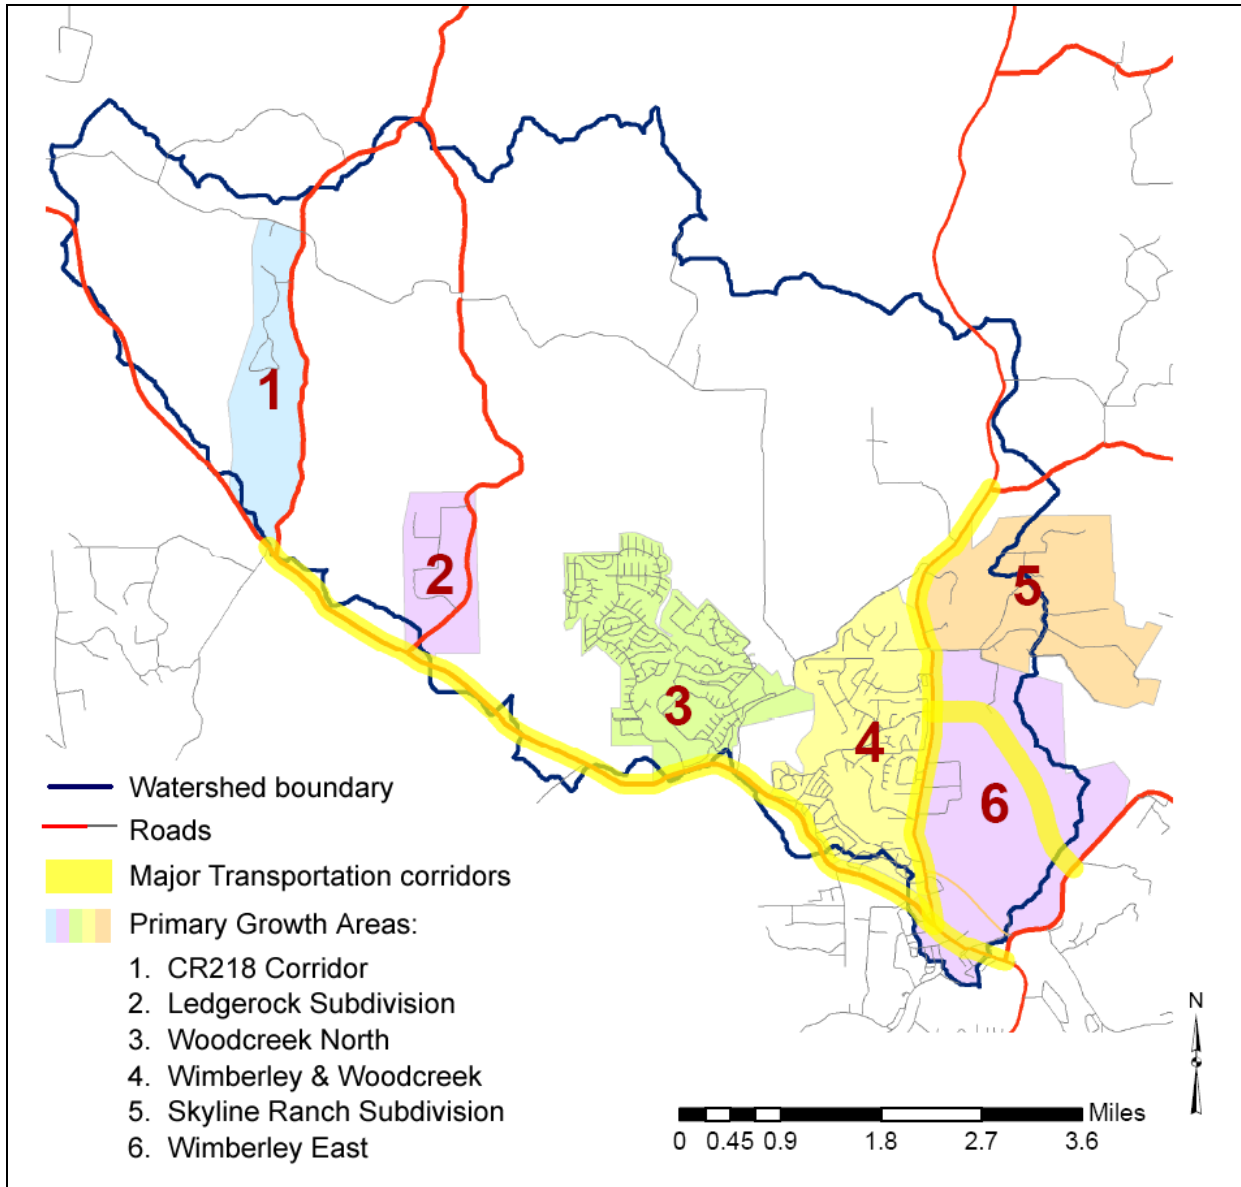
Figure 3.2. Primary growth areas in the Cypress Creek watershed.

These areas are based on existing road networks, Hays County’s 2025 Transportation Plan, city limits and extra-territorial jurisdiction areas (ETJs), water and wastewater service areas, existing parcel boundaries, and input from the DSS/Technical Subcommittee.

The primary growth areas shown in Figure 3.1 are based on existing road networks, Hays County's 2025 Transportation Plan, city limits and extra-territorial jurisdiction areas (ETJs), water and wastewater service areas, and existing parcel boundaries. Major transportation corridors were defined as 150 m (approximately 500 ft) buffers along both sides of roadway. The primary growth areas (Figure 3.2) are:

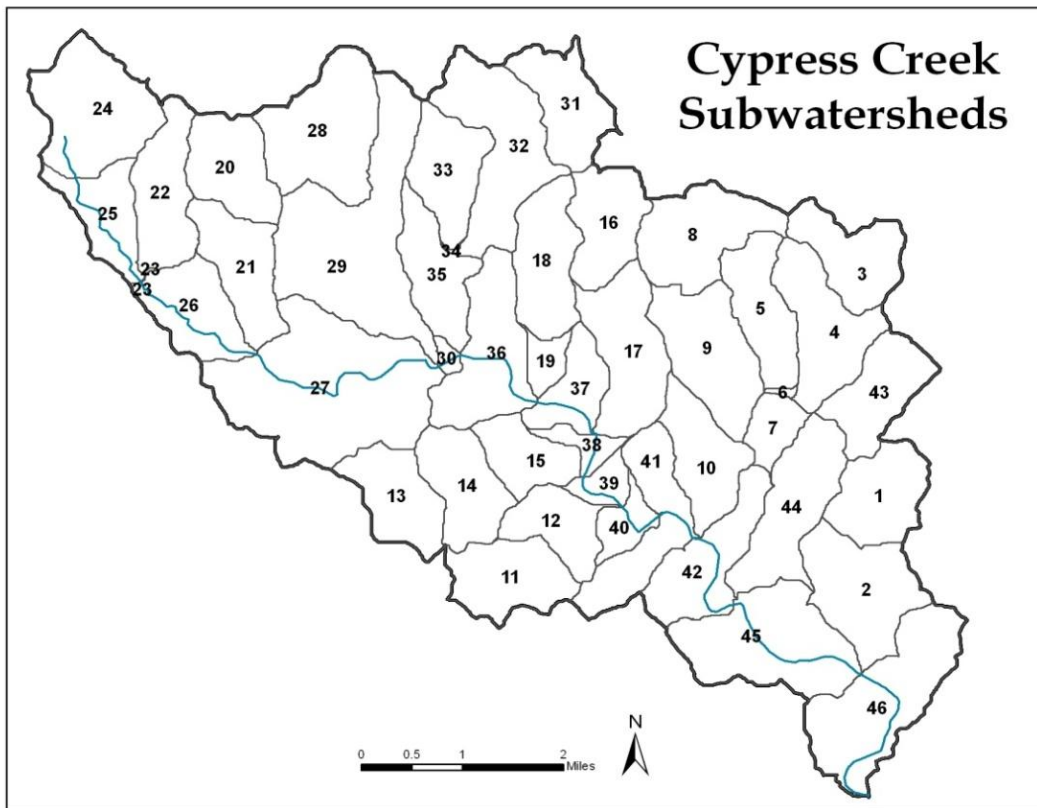
Figure 4.1. Subwatershed delineation map.

AGWA's delineation tool requires an elevation raster, which was obtained from the USGS's National Map Seamless Server (USGS, 2010). This data set has a resolution of approximately 10 meters and is processed to filter artifacts and fill missing data at quadrangle seams. Automatic delineation uses a threshold method of contributing source areas (CSA) to delineate hydrologically distinct areas. The threshold parameter may be increased to decrease the number of sub-basins, or conversely, decreased to increase the number of sub-basins. CSA was varied from 1.0% (243 acres) to 2.5% (608 acres). In addition, stormflow gauge locations were used to create breaks between watersheds so that model output at those locations can be directly compared to measured values. The resulting delineations were compared to roads and other infrastructure to choose the best balance between the number and resolution of basins and potential watershed management units. The final delineation is 46 subwatersheds within the watershed of Cypress Creek (Figure 4.1). This subwatershed delineation was used to calculate statistics for soils, land uses, and pollutant loadings.

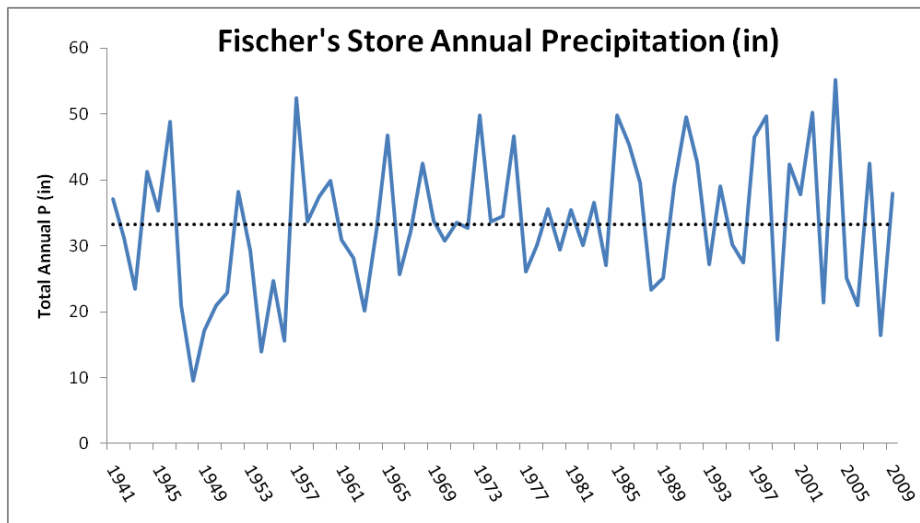
Figure 4.2. Annual precipitation, Fischer’s Store (1941-2009).

year was wet then the next year was likely to be wet as well. Beginning in 1990, however, a very wet year is more likely to be followed by a very dry year. If this trend continues it could have implications for both water management and water quality in the Cypress Creek.

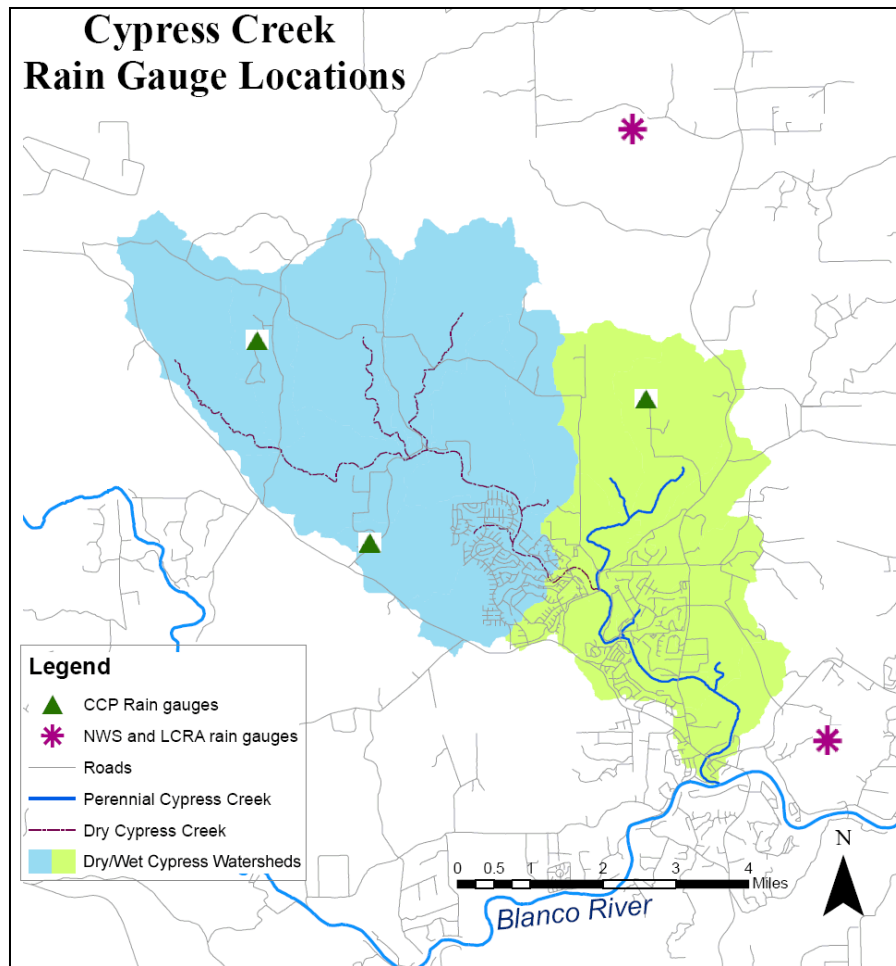
Figure 4.3. Rainfall monitoring stations in and adjacent to watershed.

Because of the highly variable nature of precipitation in the study area, the Cypress Creek Project installed three tipping-bucket rain gauges inside the watershed boundary to record rainfall at a higher resolution than is available with National Weather Service data (Figure 4.3). Rainfall data has been collected at these stations since September 2009. The results suggest that rain can be highly variable even within the small watershed area; one storm in January 2010 recorded 2.2 and 2.8 inches of rain at the two northern gauges, while the southern gauge recorded 0 inches. This north-south gradient is common in the data, as indicated from the results of a linear regression calculated on daily total precipitation at various weather stations. A linear regression is a statistical tool that compares values for two datasets and indicates how good one term is at predicting the value of another term. The “goodness-of-fit,” or R^2 value, is a measure of how well the linear regression describes the relationship between the two data sets. If daily precipitation recorded at two stations is always the same, the R^2 value would approach 1. R^2 values closer to 0 indicate that the values measured were very different. In this study, linear regression was used to see how closely the precipitation recorded at various weather stations compared to each other. In general, the northern two gauges are similar ($R^2 = 0.83$) but quite different from the rain recorded at Wimberley ($R^2 = 0.16$ and 0.29). Data at the southern gauge are more closely correlated to rain recorded at Wimberley ($R^2 = 0.37$) and, within a range of variability over time, can be very different from rain data recorded at the upper two gauges. Therefore, relying upon the weather station at Wimberley and Fischer’s Store may be adequate for long-term annual and monthly averages, but to understand historic and probable future daily rainfall patterns within the Cypress Creek watershed, a higher resolution is necessary to capture the natural spatial variability in the area.

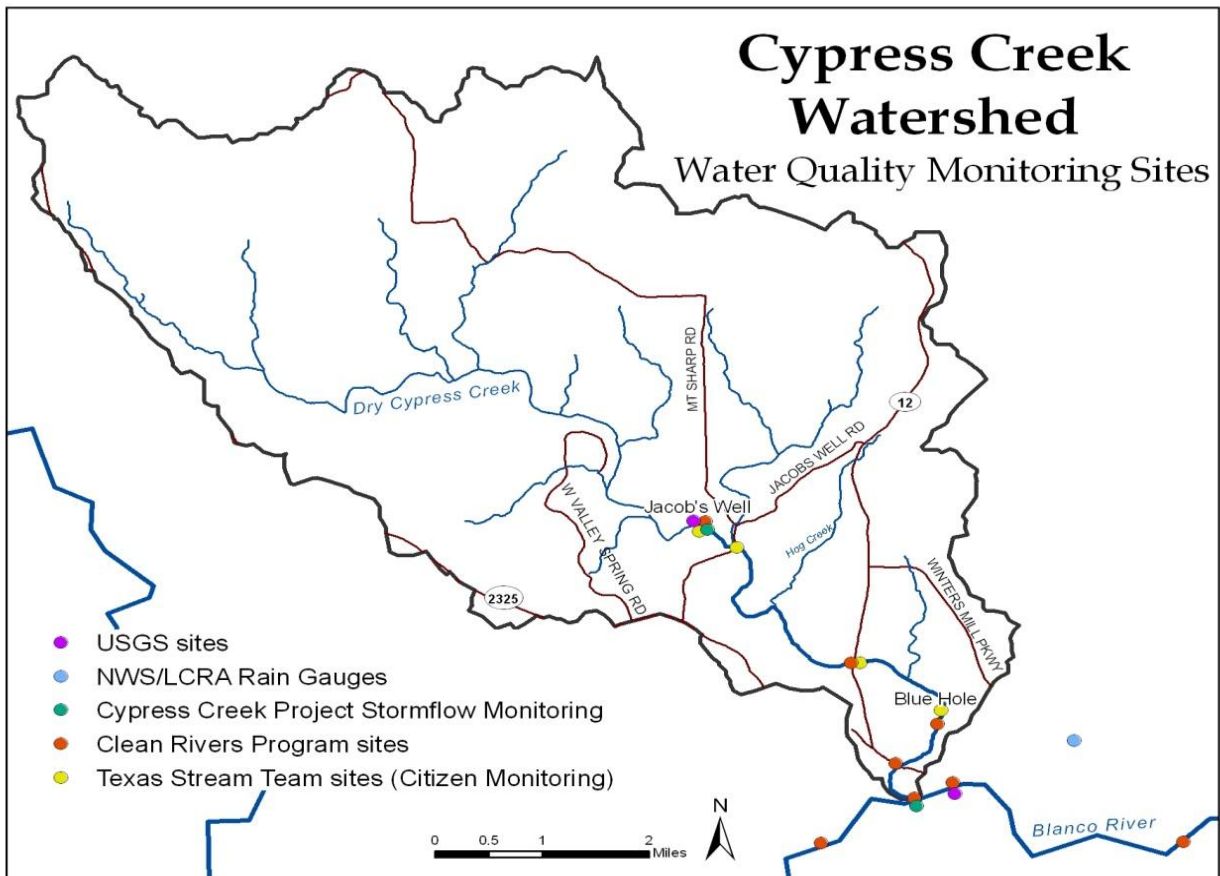
Figure 4.4. Water quality monitoring sites.

To help address these data gaps, the Cypress Creek Project installed two automatic stormflow monitoring devices along the main creek channel to record stage, sediment, nutrient, and bacteria concentrations during runoff events (Figure 4.4). One station draws samples from Cypress Creek near its confluence with the Blanco River, and a second station draws samples from the low water crossing at Woodacre Drive, about 100 yards upstream of Jacob's Well. The stations consist of a large metal box (about 2ft x 2ft x 3ft) which is attached to a metal platform. The sampler inside the box connects to plastic tubes running through gray electrical conduit down to the creek. An ISCO 730 bubbler flow module inside continually records the height of water ("stage") every five minutes, and triggers a pump to start collecting water samples when an increase in flow is detected, indicating that runoff has started from a rain storm. The samples are later taken to a lab and tested for sediment, analyzed in the lab for total suspended solids (TSS), nitrate-nitrogen, total phosphorus, and *E. coli*.

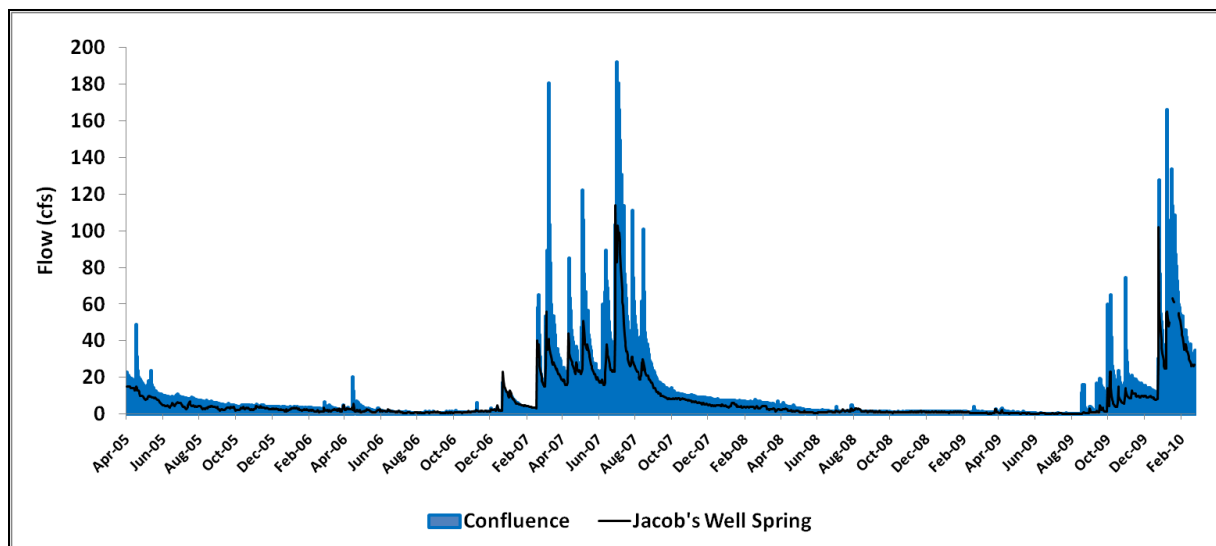
Figure 4.5. Flow estimated at the Cypress Creek confluence and recorded at Jacob's Well Spring (April 2005 – February 2010).

Flows estimated using the above method were compared to recorded instantaneous flows, and the resulting error ranged from -2.5% to 11.9%. This method was used to estimate historical daily mean flows for the Cypress Creek for January 2000 to February 2010. The resulting estimated flows are correlated very strongly with recorded spring flow at Jacob's Well starting in April 2005 (R^2 of linear regression = 0.86, $n = 1,745$; see Figure 4.5).

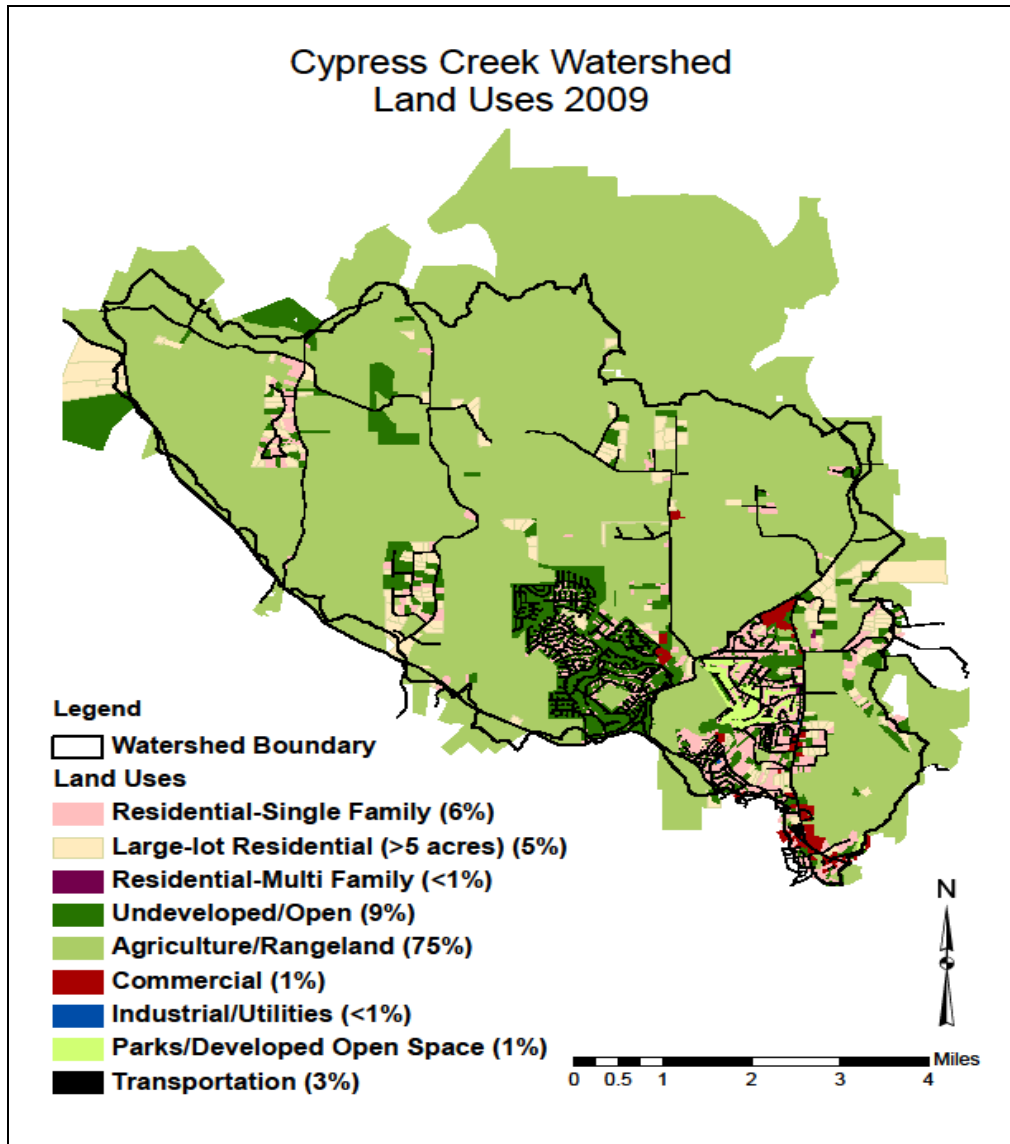
Figure 4.6. Land use in Cypress Creek watershed, 2009.

Land Use Type	Acreage	Percent
Residential-Single	1,417	6%
Residential-Large lot	1,723	5%
Residential-Multi	10	<1%
Undeveloped	2,762	9%
Agriculture/Rangeland	26,523	75%
Commercial	255	1%
Industrial	16	<1%
Parks	162	1%
Transportation	925	3%
Total	33,793
