Cypress Creek Project Watershed Characterization Report

CYPRESS CREEK WATERSHED PROTECTION PLAN

Characterization Report

**The River Systems Institute
Texas State University-San Marcos**

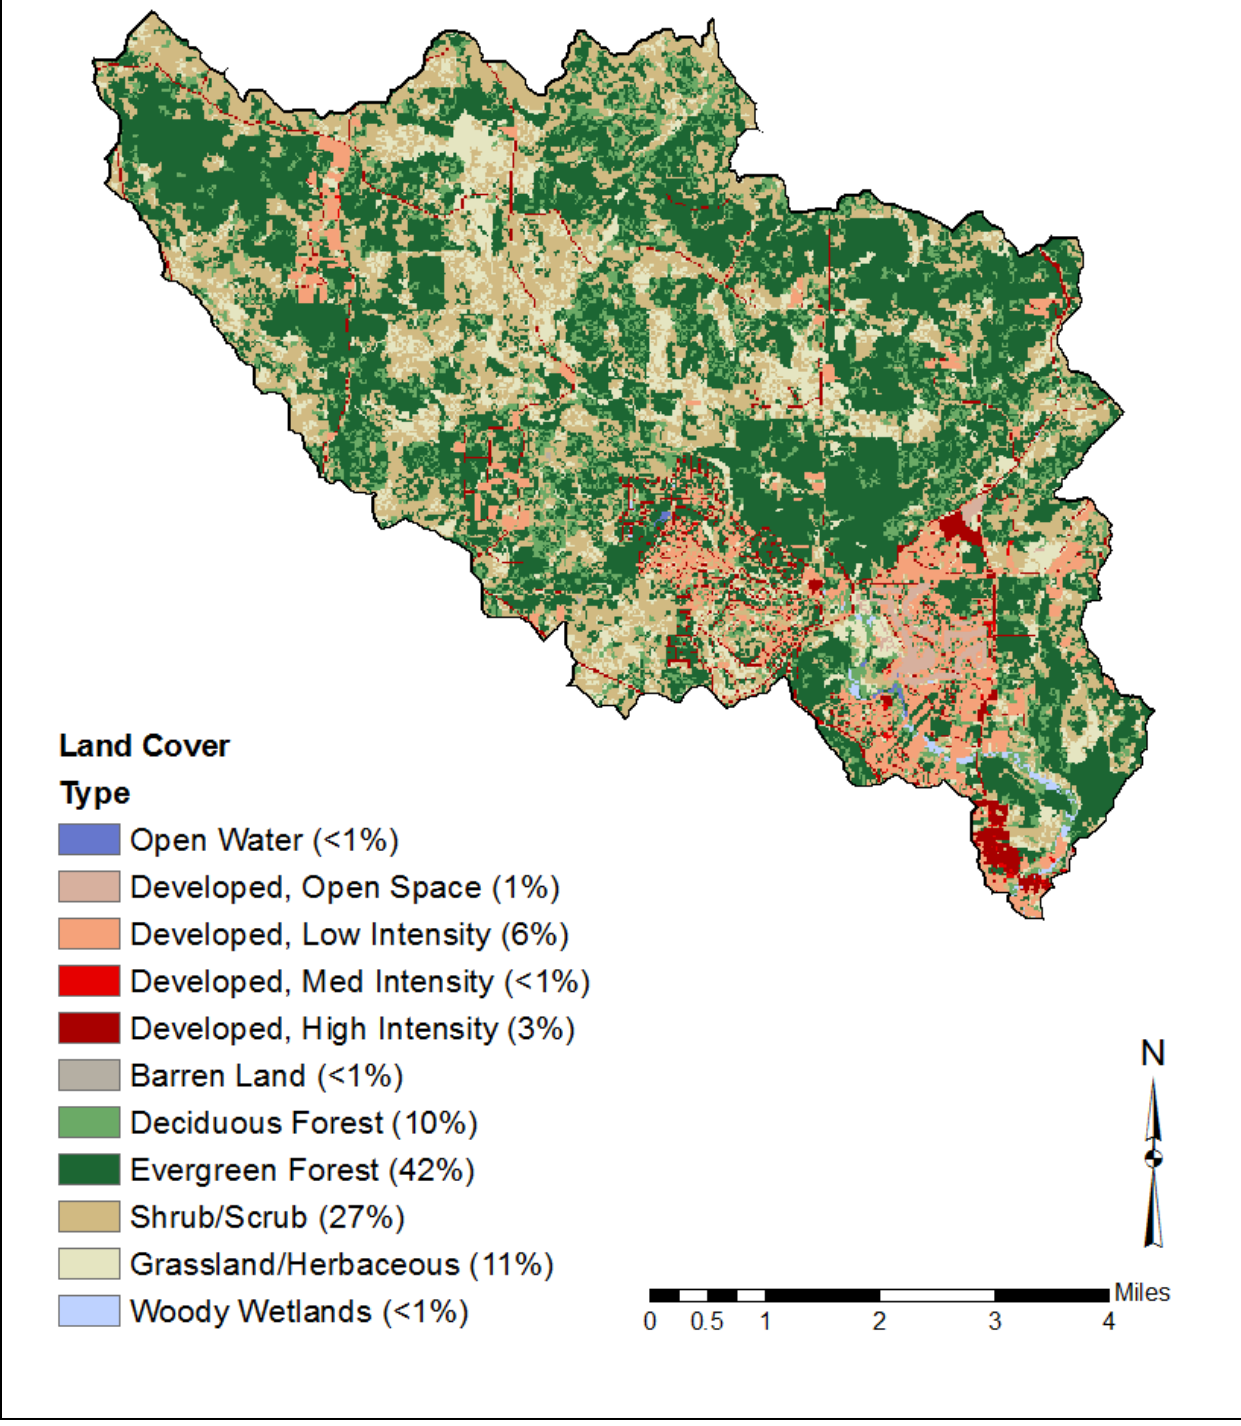
Figure 4.7. Land cover in the watershed, 2009.

to be classed as Medium or High Intensity development, or in some cases Developed, Open Space. Finally Transportation land uses were converted to the Developed, High Intensity land cover class. We assumed that Large-lot Residential (ALg), Agriculture/Rangeland (E), and Open/Undeveloped (C) land uses would have little impact on the overall land cover, and so these areas were not changed from the 2000 base map. The results are shown in Figure 4.7.

While land use in the watershed is predominantly rangeland, the combined residential, commercial, and transportation uses account for 16% of total area (Figure 4.7). However much of this 16% is impervious surface cover, and is concentrated at the southern and eastern portions of the watershed. Increased impervious surface cover has been proven to alter hydrologic and ecologic functioning. In a recent study of land cover change from 1996 to 2005, impervious surface cover increased by 3% over the watershed (Carter, 2008). In 1996 impervious cover was calculated at 6.03% and in 2005 it was 9.04%. This is likely to have altered watershed functioning from the previous less developed states by increasing flood peaks and potentially decreasing recharge to the underlying aquifer.

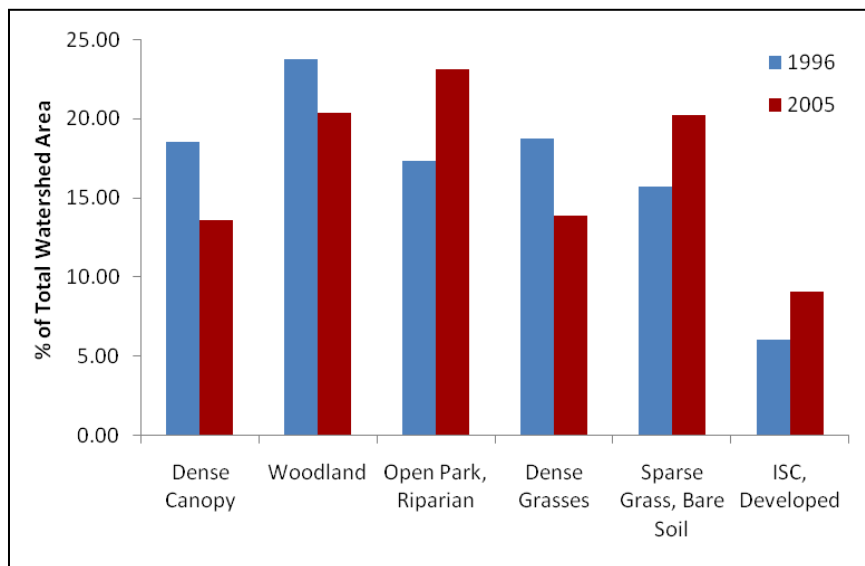
Figure 4.8. Change in relative area of six land cover classes from 1996 to 2005 (Adapted from Carter, 2008).

Other results from Carter (2008) show a pattern consistent with an urbanizing watershed. From 1996-2005, patch number increased for four out of six land cover types, while mean patch area decreased slightly. Cover classes associated with undeveloped land (dense canopy, woodland, dense grasses) declined as a percentage of total watershed area, while those associated with development (open park, sparse/bare soil, and impervious cover) increased in their relative area (Carter, 2008; Figure 4.8). Overall, an increase in impervious cover and decrease in average patch size for other land cover classes indicate a typical pattern of landscape fragmentation as urban development encroaches on previously open areas. In addition, landscape fragmentation caused by anthropogenic activity can have profound effects on biotic communities, ecological processes, and hydrologic functioning. There is also some indication that clearing of previously forested areas may have occurred, though conclusions are not entirely reliable given limitations of the remote sensing approach used for analysis. Additional analysis will need to be done to determine the spatially distributed impacts of this change across the watershed, though it is clear that the largest increase in ISC from urban development has occurred in the lower portions of the watershed around Wimberley, Woodcreek and Woodcreek North, and much of the projected development is expected to occur in these areas along major transportation routes such as RR12 and RR2325.

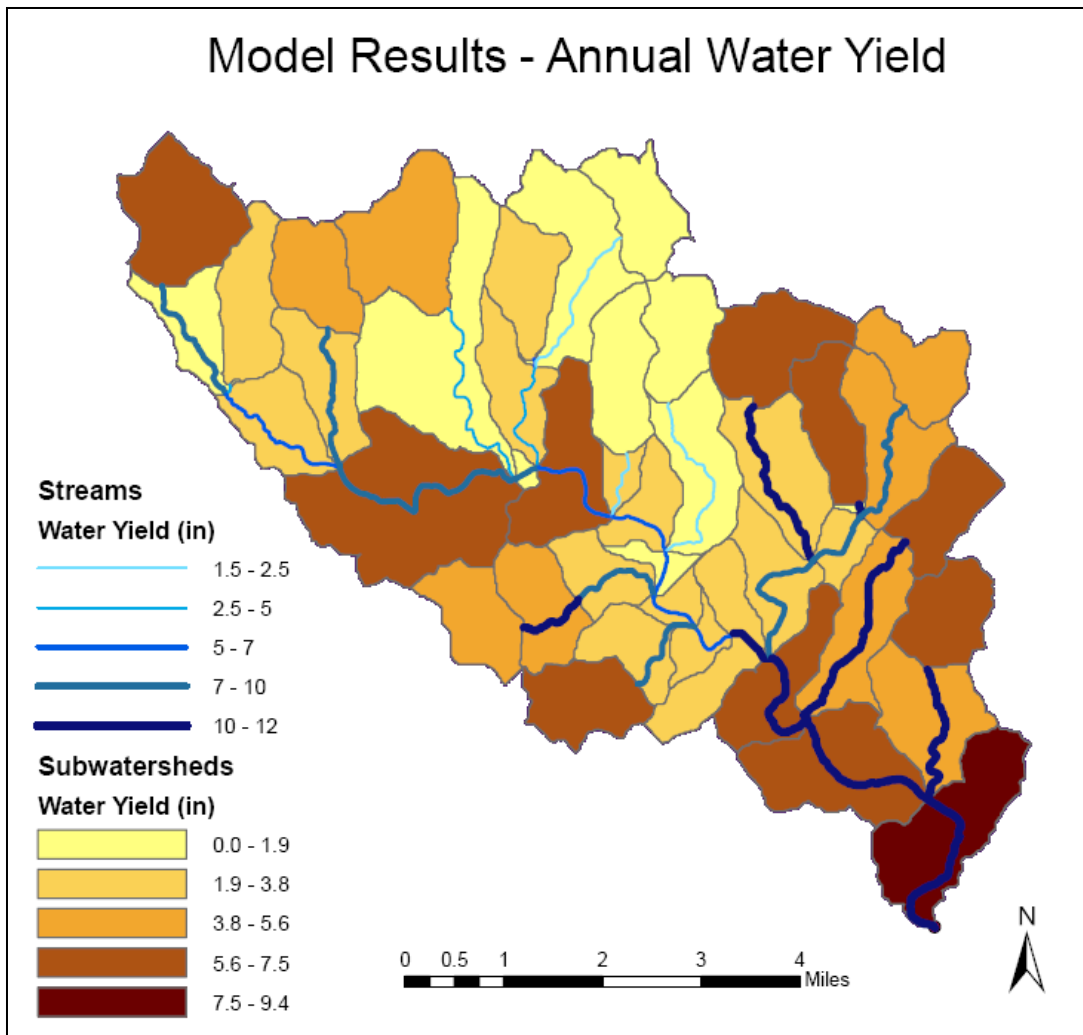
Figure 4.9. Simulated average water yield by subwatershed and reach, 2000-2009, using the SWAT hydrologic model.

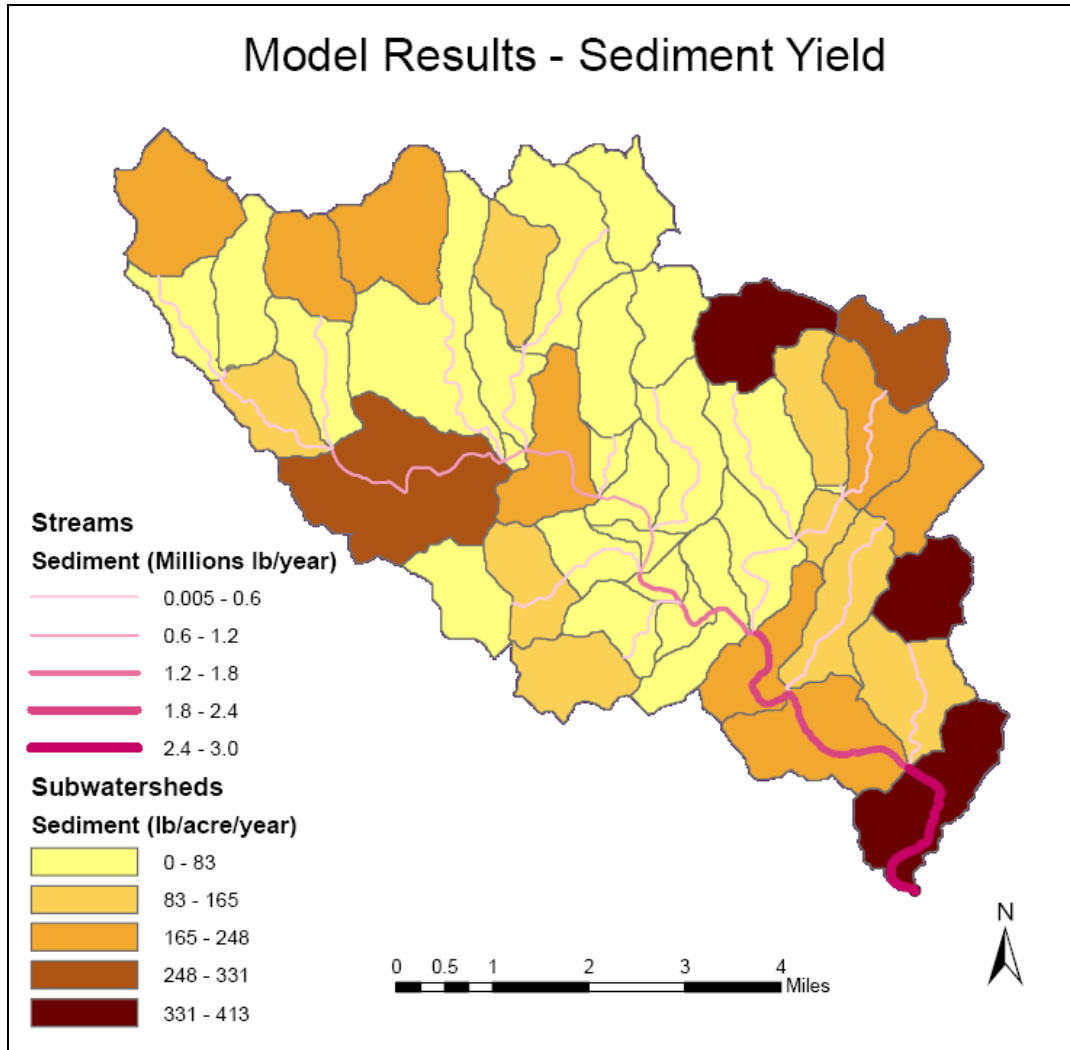
Figure 4.10. Simulated average sediment yield by subwatershed and reach, 2000-2009, using the SWAT hydrologic model.

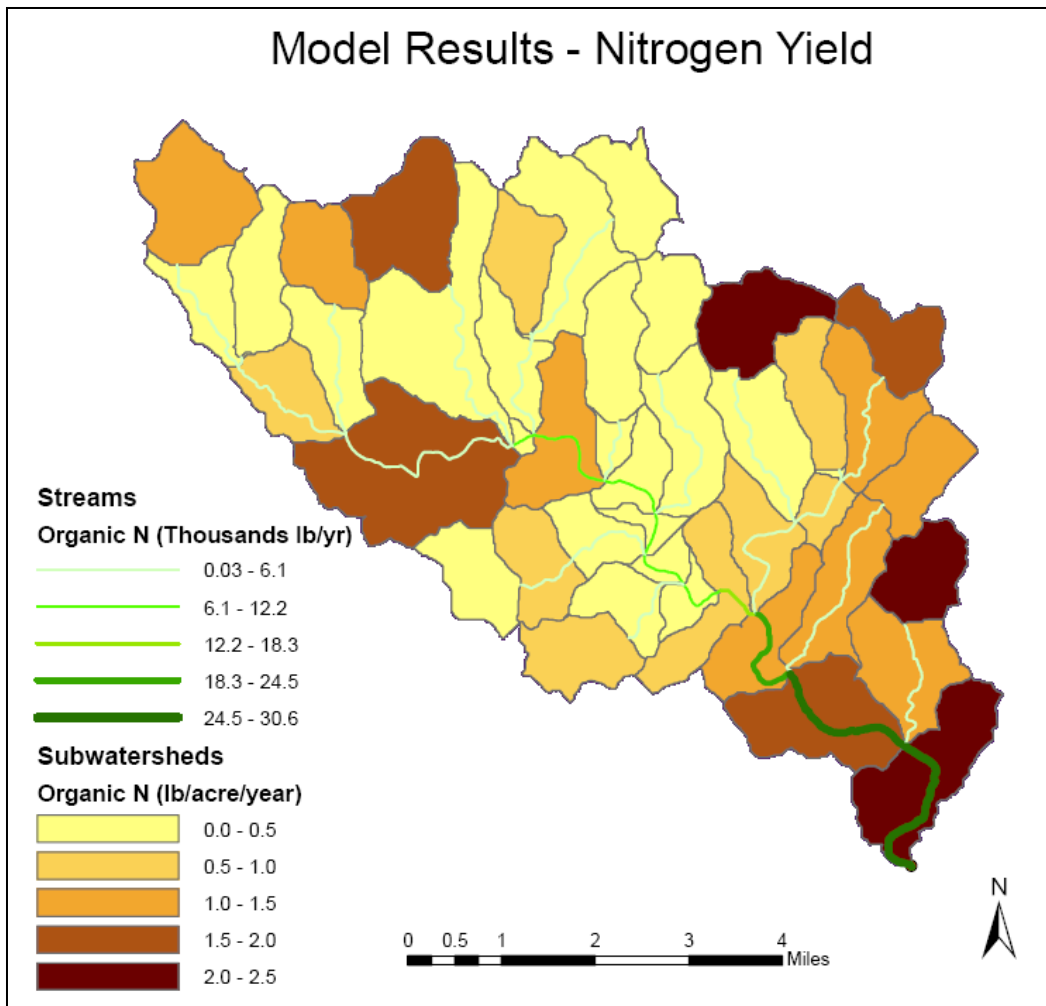
Figure 4.11. Simulated average organic nitrogen yield by subwatershed and reach, 2000-2009, using the SWAT hydrologic model.

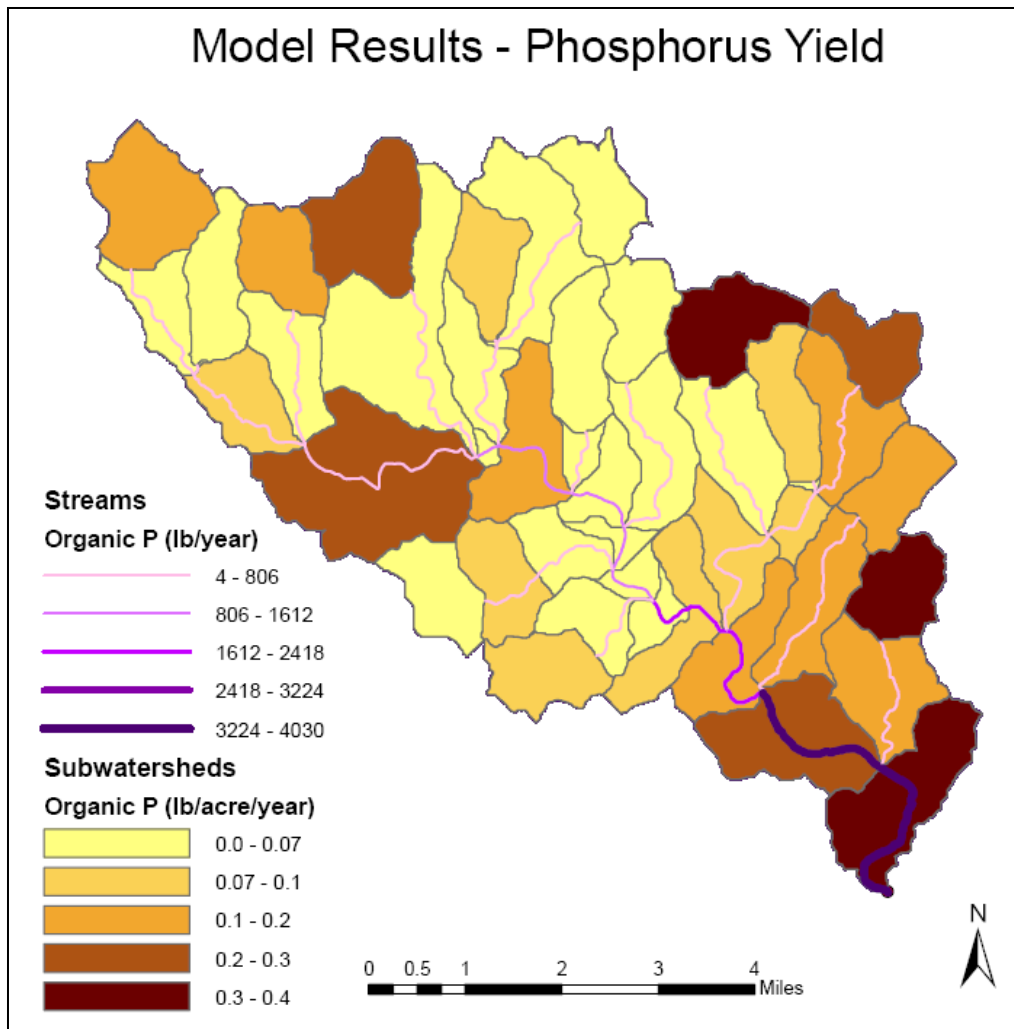
Figure 4.12. Simulated average organic phosphorus yield by subwatershed and reach, 2000-2009, using the SWAT hydrologic model.

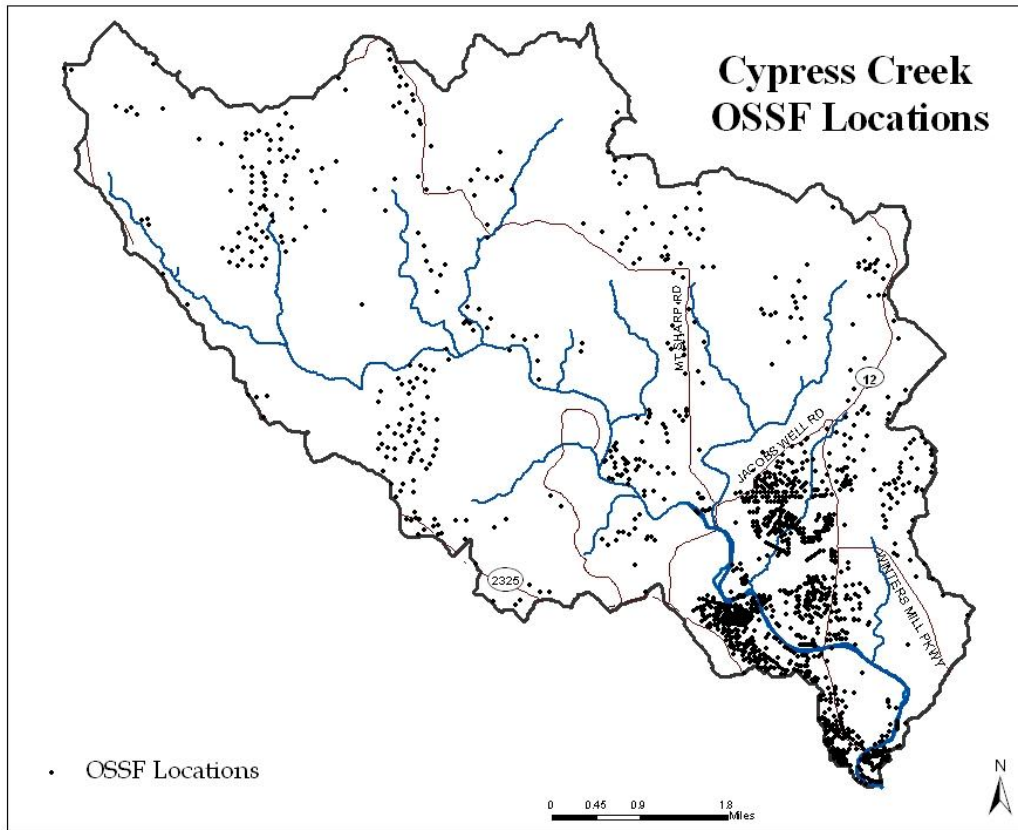
Figure 5.2. Locations of OSSF in the Cypress Creek Watershed.

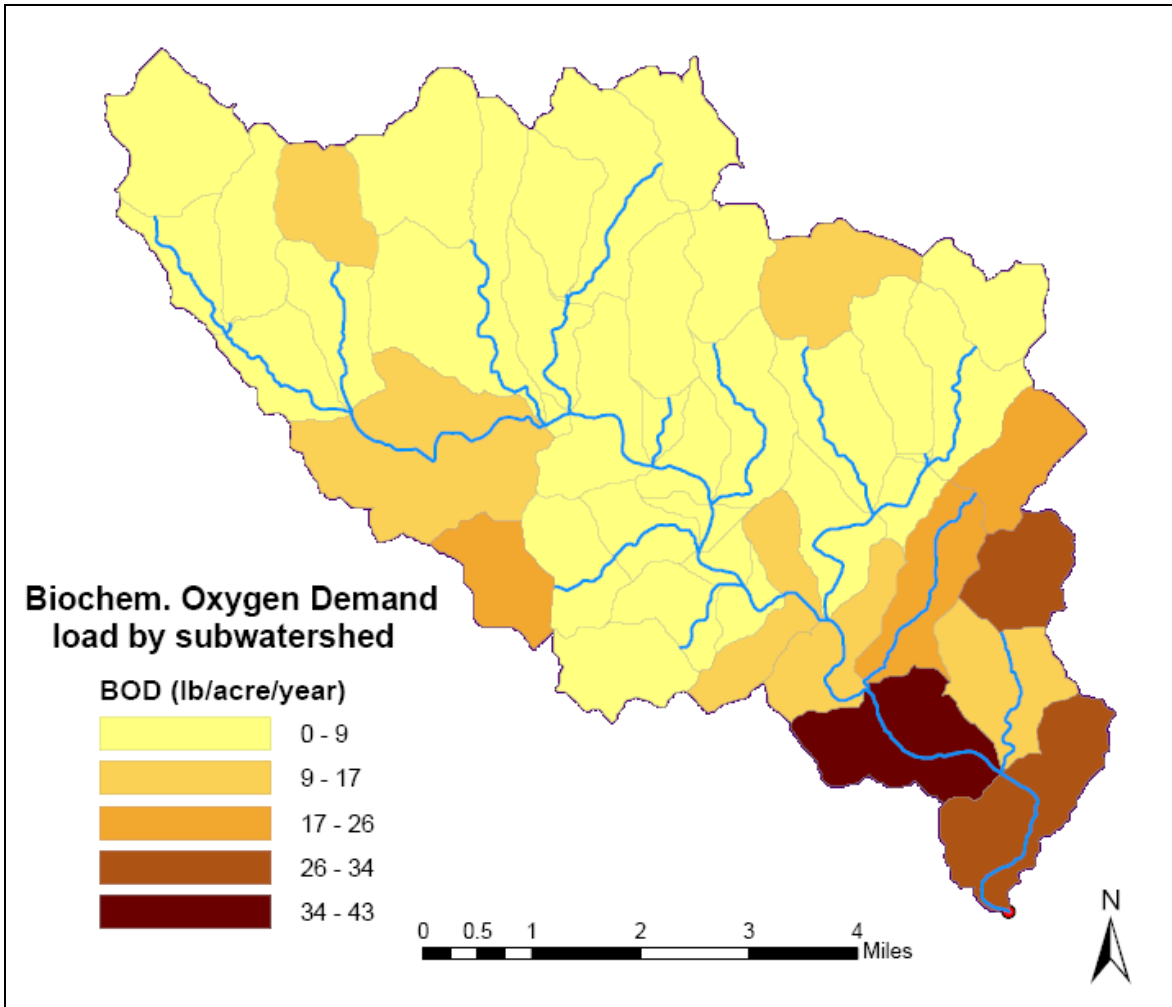
Figure 5.3. Biochemical oxygen demand, estimated load by subwatershed.

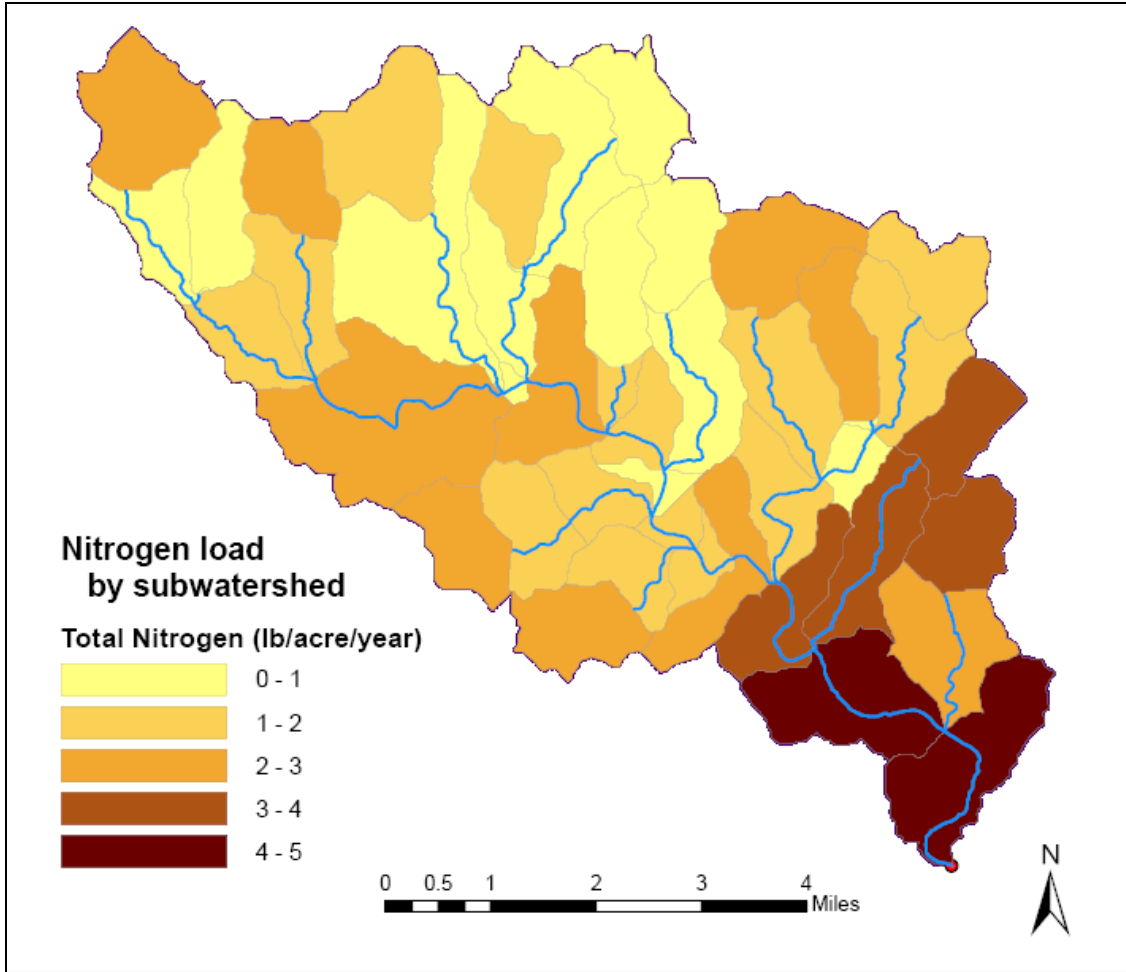
Figure 5.4. Total nitrogen, estimated load by subwatershed.

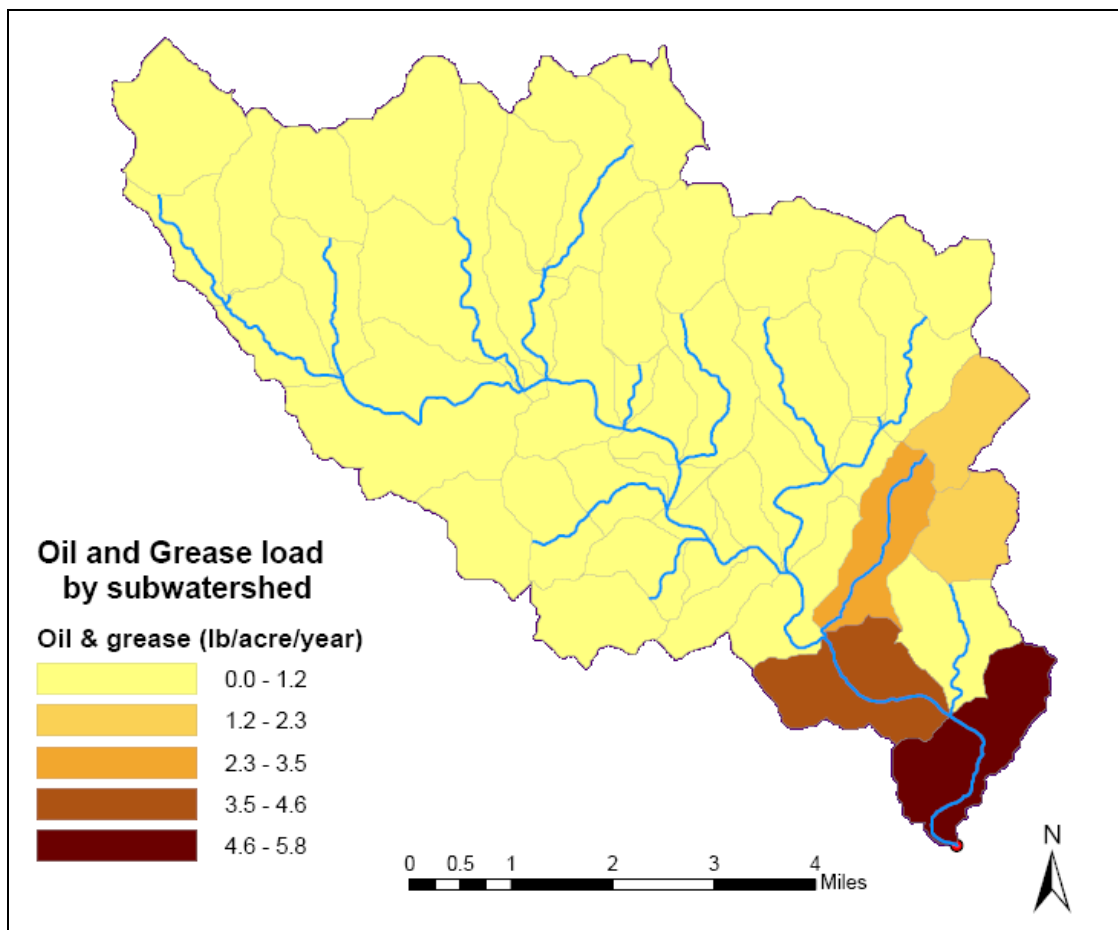
Figure 5.5. Oil and grease, estimated load by subwatershed.

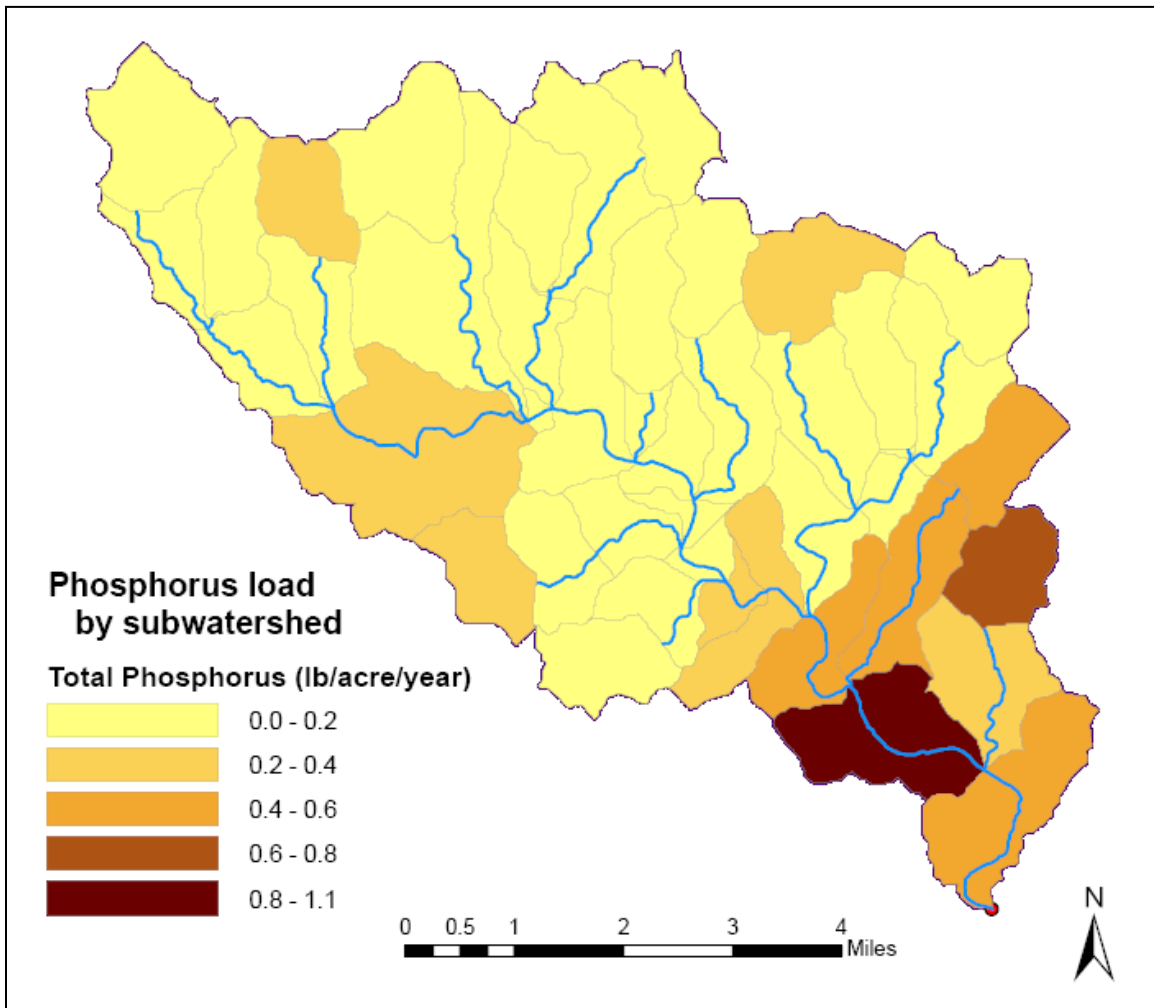
Figure 5.6. Total phosphorus, estimated load by subwatershed.

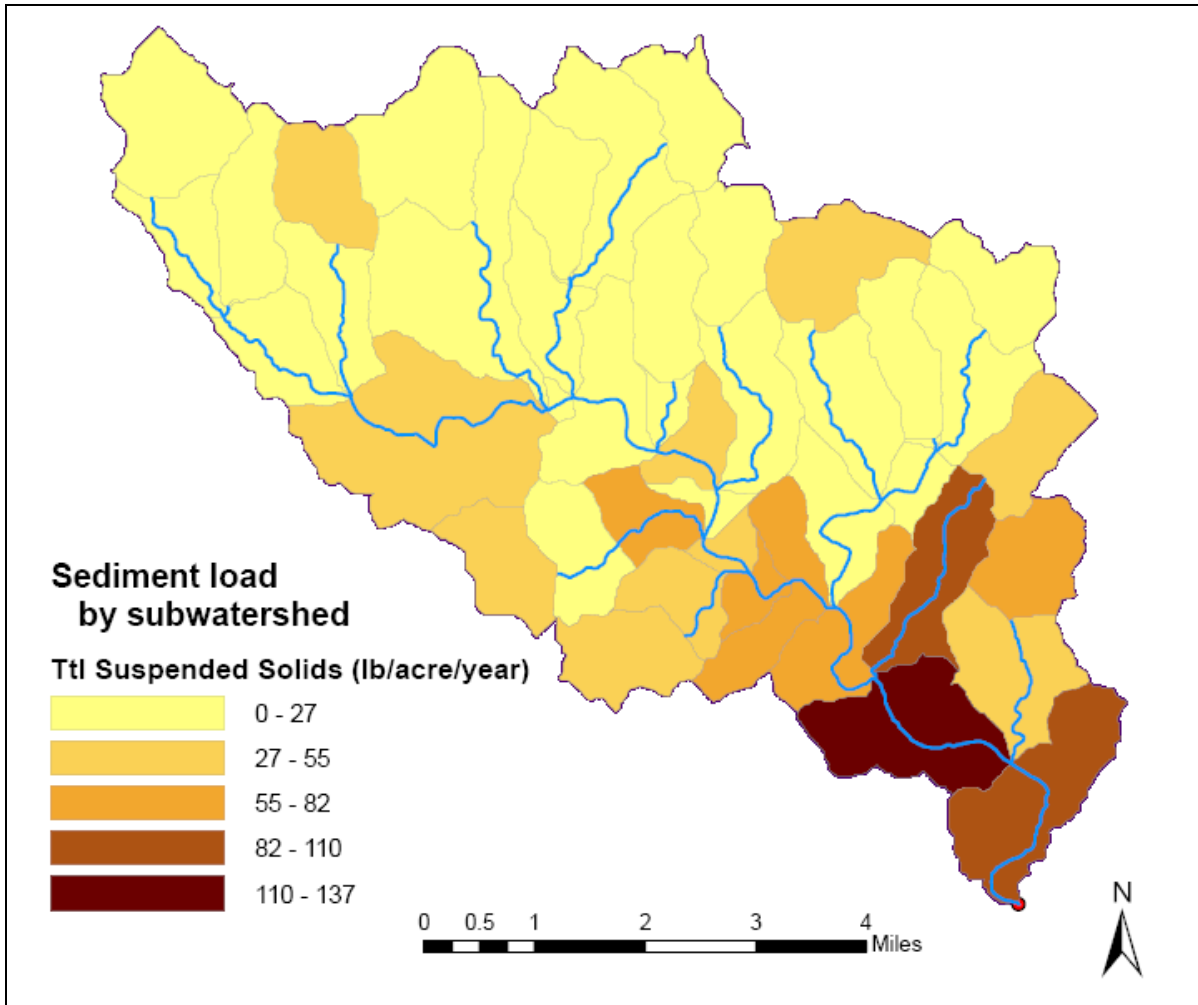
Figure 5.7. Total suspended solids, estimated load by subwatershed.

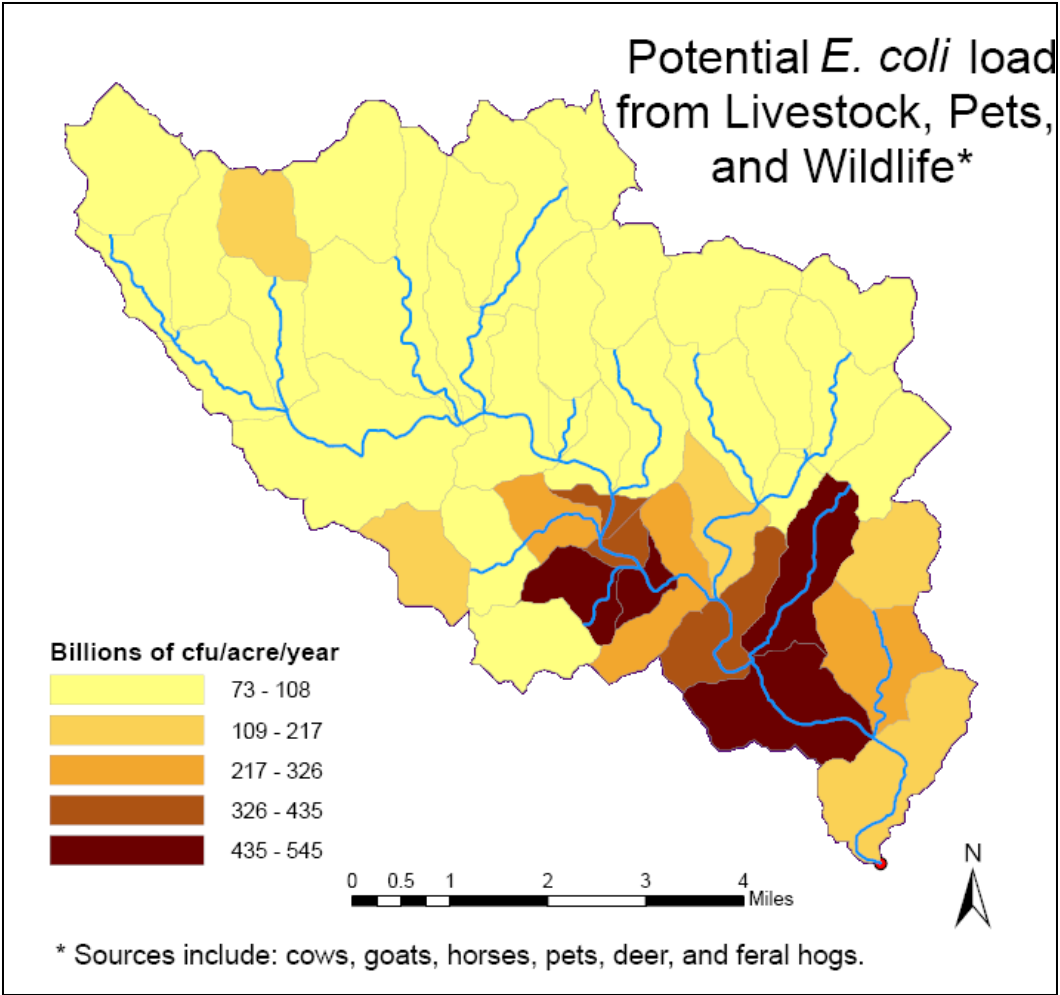
Figure 5.8. Potential *E. coli* load from livestock, pets, and wildlife.

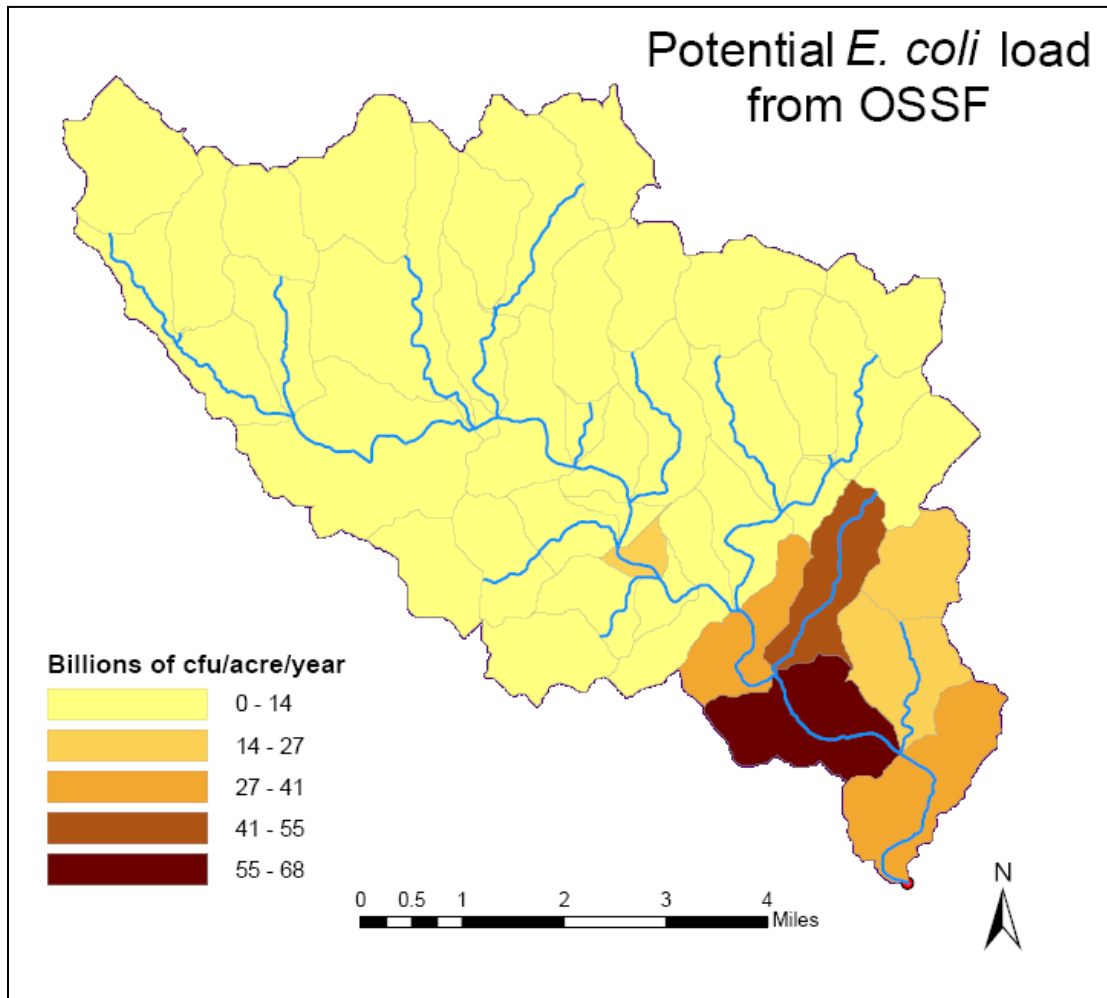
Figure 5.9. Potential *E. coli* load from OSSF.

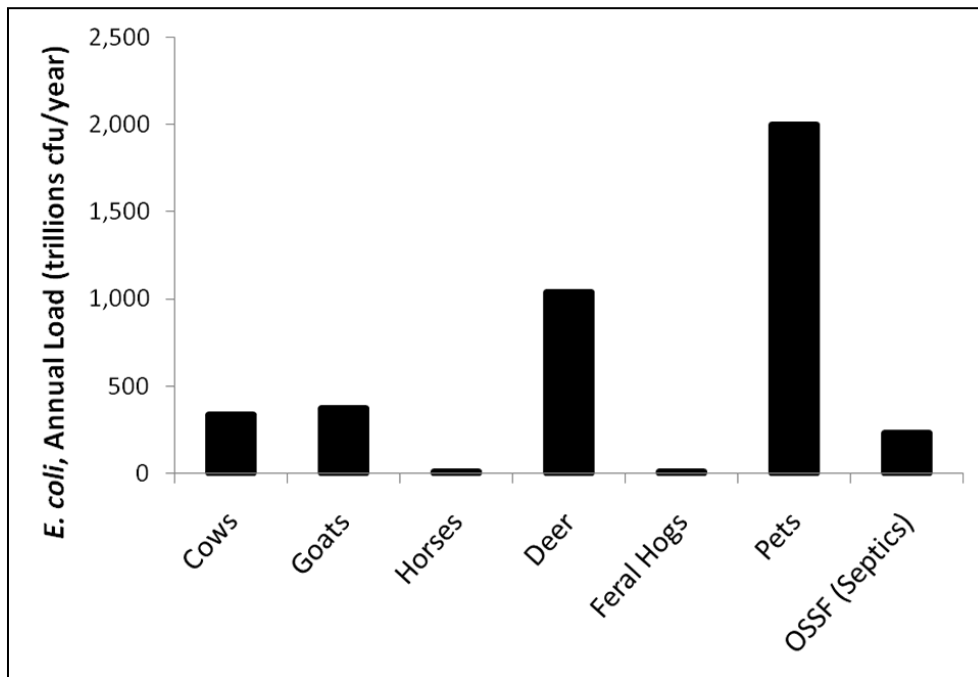
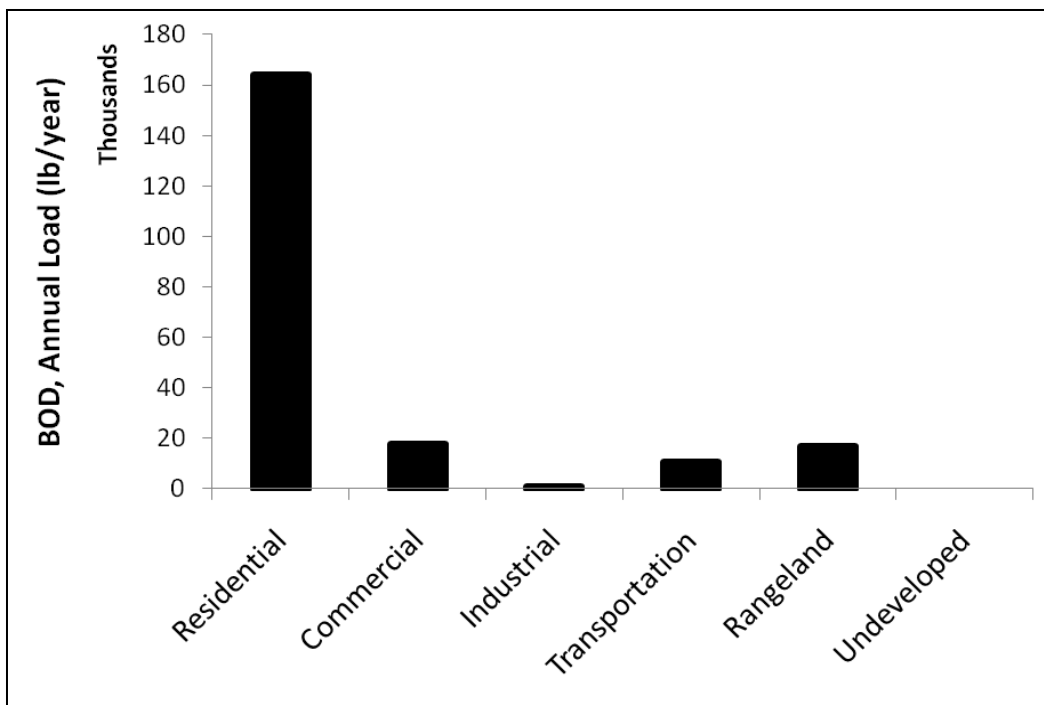
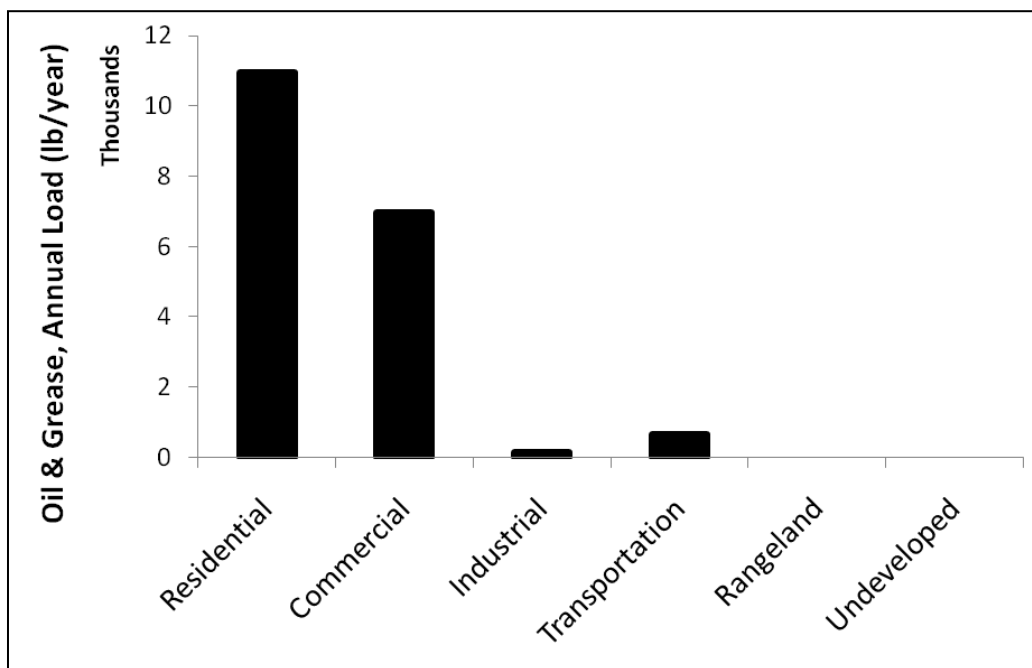
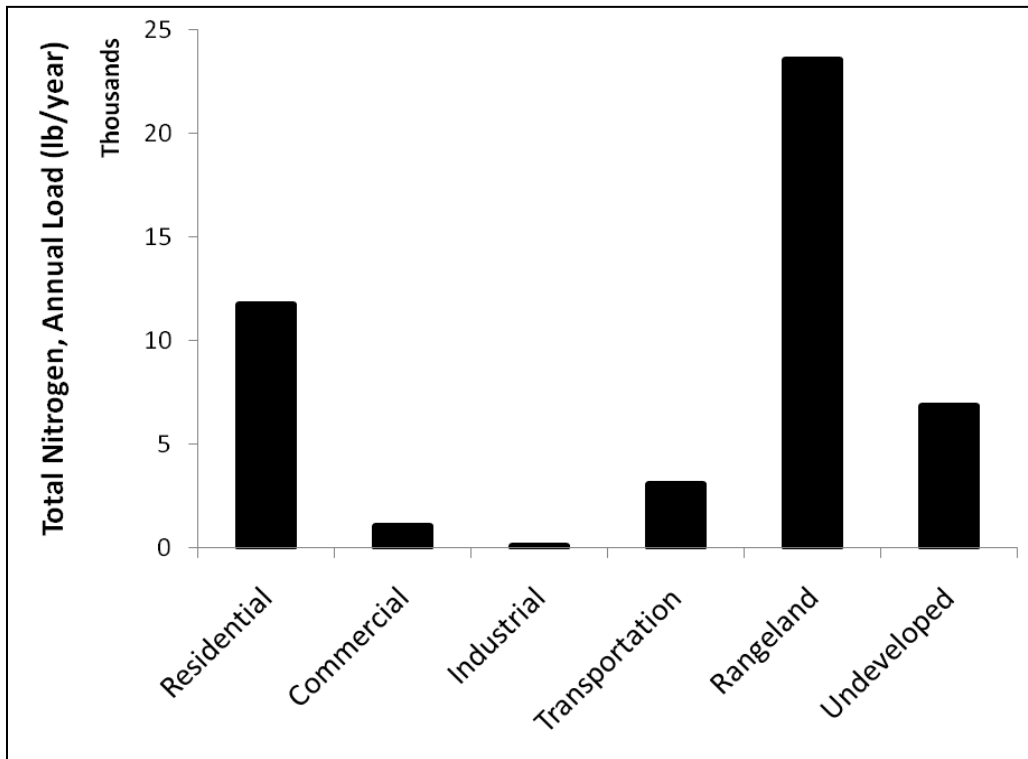
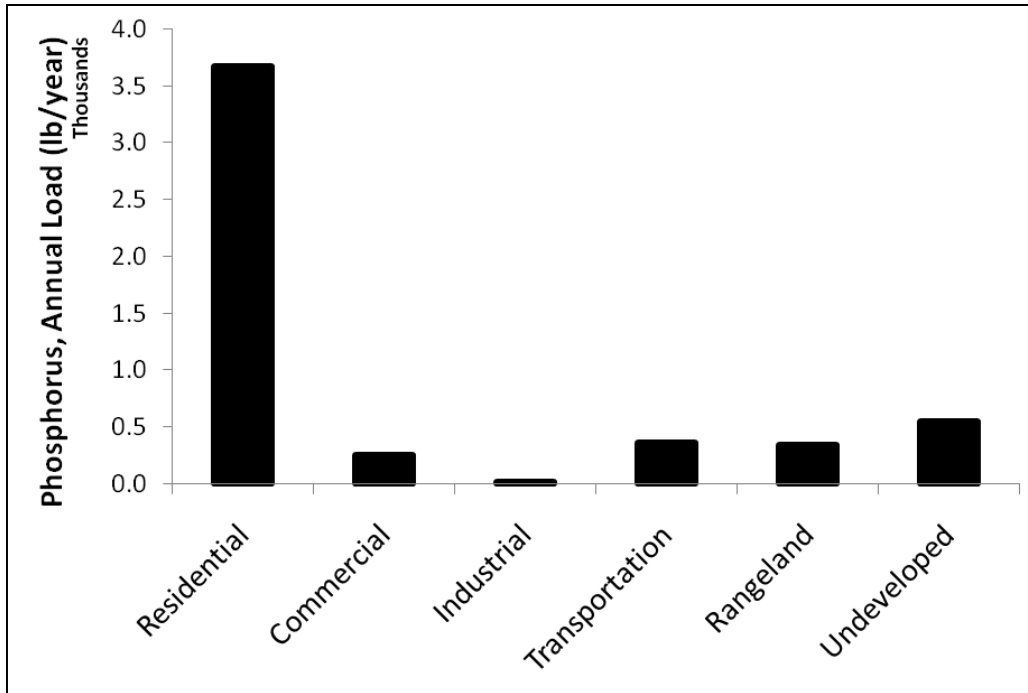
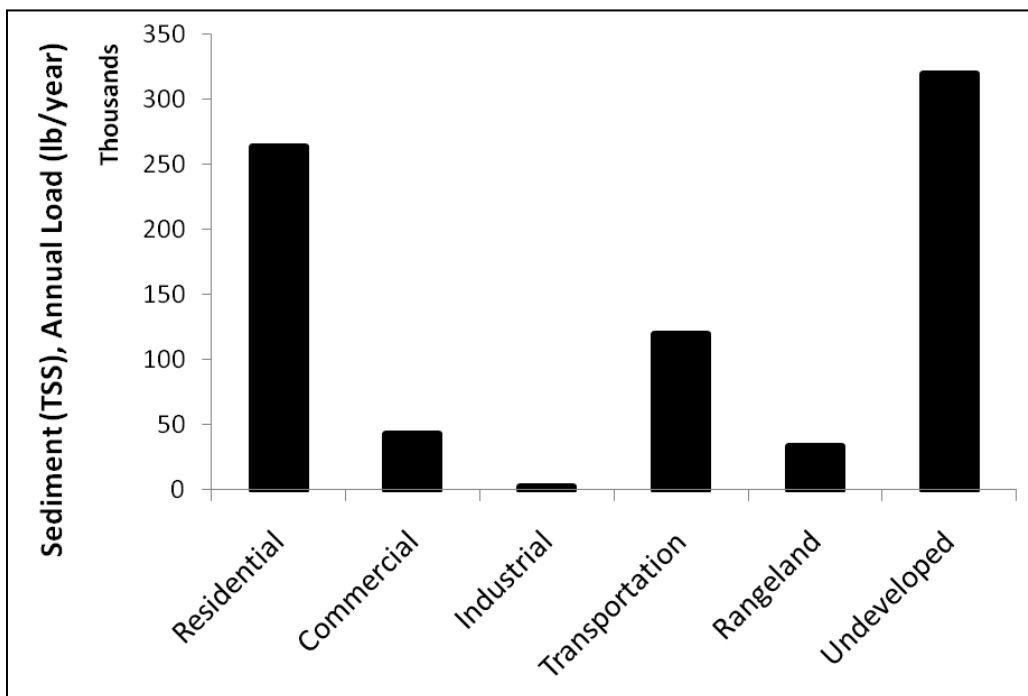
Figure 5.10. Total potential *E. coli* load by source for watershed.

Figure 5.11. Total potential BOD load by land use for watershed.

Figure 5.12. Total potential Oil and Grease load by land use for watershed.

Figure 5.13. Total potential nitrogen load by land use for watershed.

Figure 5.14. Total potential phosphorus load by land use for watershed.

Figure 5.15. Total potential Sediment load by land use for watershed.

Based on the land use and pollutant loading analysis described above, the following figures show total annual pollutant loading potential for six parameters: *E. coli*, BOD, oil and grease, total nitrogen, total phosphorus, and sediment (Figures 5.10-5.15). These figures illustrate the relative magnitude of the pollution load contributed from various sources and land uses. Land uses with the highest relative contribution should be targeted in watershed protection planning for BMPs that address those parameters of concern. For example, pets and deer are the largest sources of *E. coli* identified in the watershed, while residential land use is the largest contributor to BOD loadings. Therefore educating pet owners about picking up animal waste, limiting fertilizer applications, and controlling deer populations will be most effective in mitigating these problems. Nitrogen and sediment come predominantly from Rangeland and Undeveloped land uses, so BMPs for sediment retention and proper range management are recommended for those areas.

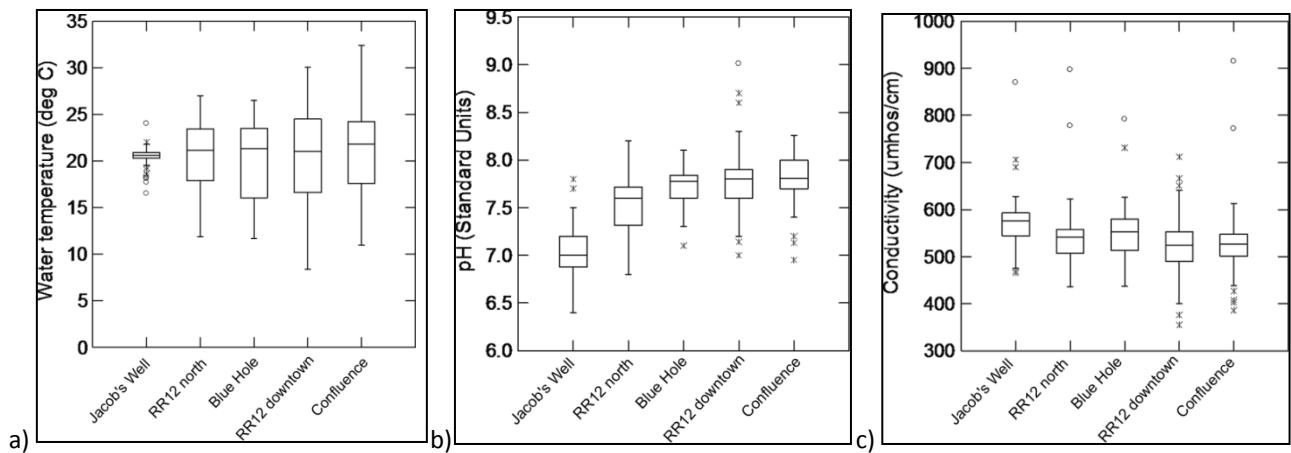
Figure 6.1 (a,b,c). Water chemistry-related parameters.

Parameters were measured at five sites along the Cypress Creek: a) water temperature; b) pH; and c) conductivity. Lines through the center of boxes represent the median value, bottom and top of boxes represent the 25th and 75th percentiles, respectively, and whiskers show the 5th and 9th percentiles. Dots are outlying values.

Median water temperatures are lowest at Jacob's Well (20.6 °C) and at Blue Hole (21.3 °C), where spring flows provide fresh inflows of groundwater to the creek. There is increasing variability in temperature downstream from the headwaters, and the highest median temperatures are at the confluence site (21.8 °C). The hottest water temperature on record was 52.6 °C in July 2001, at RR12 in downtown Wimberley. At the confluence, the next highest temperature of 32.4 °C was recorded in June 2009. 99% of samples fall below the TCEQ standard of 30 degrees maximum temperature for the segment. The majority of temperature readings fall in a relatively narrow range between 17 and 24 °C (Figure 6.1 a). Temperature is more highly variable as you move downstream, indicating the influence of air temperature and solar radiation as the channel widens downstream.

Measurements of pH generally increase downstream from Jacob's Well, while specific conductance generally decreases (Figures 6.1 b, c). This pattern is typical of this type of karst spring run, which has a near-constant inflow of cold groundwater at Jacob's Well and from numerous small springs and seeps along its course and feeding in from major tributaries. Highly variable readings of pH at the downtown site and the confluence suggest that other nonpoint source pollutants may be impacting water chemistry as the creek flows through downtown Wimberley.
