Cypress Creek Project Watershed Characterization Report

CYPRESS CREEK WATERSHED PROTECTION PLAN

Characterization Report

**The River Systems Institute
Texas State University-San Marcos**

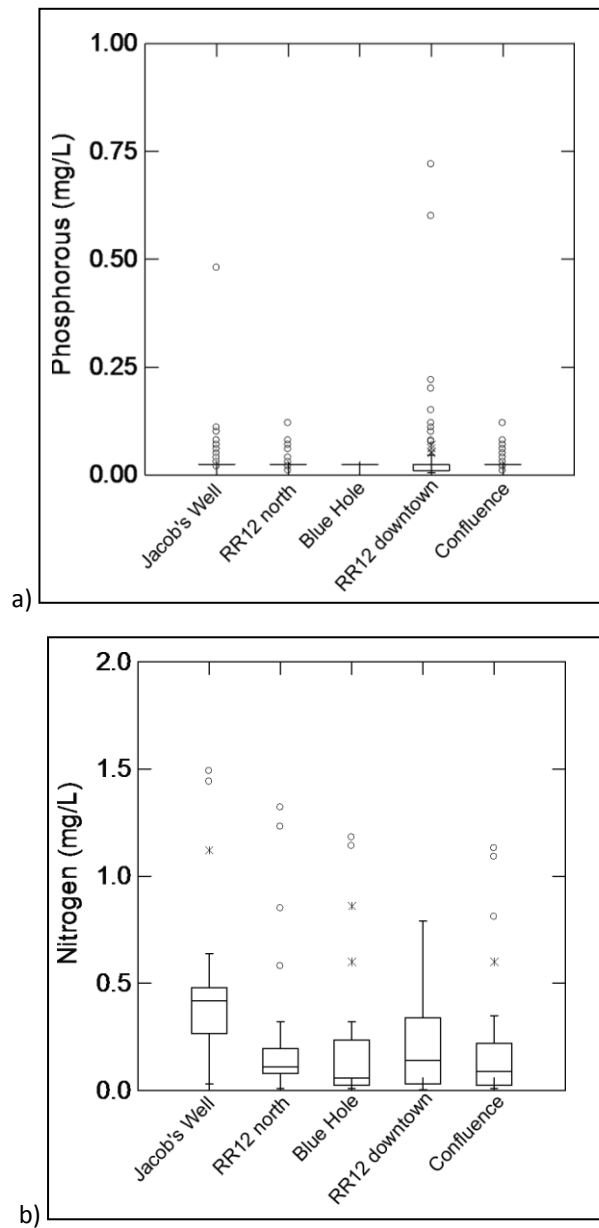
Figure 6.2 (a,b). Phosphorus and nitrogen data.

Box-and-whisker plots that show the variability of a) phosphorus (mg/L) and b) nitrogen (mg/L) measured at five sites along the Cypress Creek. Lines through the center of boxes represent the median value, bottom and top of boxes represent the 25th and 75th percentiles, respectively, and whiskers show the 5th and 9th percentiles. Dots are outlying values.

Ambient concentrations of nutrients (nitrate-nitrogen, phosphorus, ammonia) are at very low levels in the perennial Cypress Creek. Median values of phosphorus are 0.025 mg/L at all sites, which means that in reality they are below the laboratory detection limit of 0.05 mg/L. For all sites, phosphorus remains below 0.05 mg/L in 83% of samples. The highest P values and the most variable are measured at RR12 downtown, with a maximum of 3.06 mg/L (Figure 6.2a,b). Phosphorus has never been measured above detection limits at Blue Hole. The load duration curve for P shows that load exceedances tend to occur at medium to low flows, and primarily at downtown Wimberley (Figure 6.3). These lower flow exceedances often occur in mid-winter and mid-summer (January and June). However most of the elevated phosphorus levels (>0.05 mg/L) occurred between 1998 and 2004. Since 2004 only one exceedance has occurred at Jacob's Well in December 2008 and at RR12 downtown in January 2010. At the Jacob's Well site this corresponds to a time when flows were reduced to about 1 cfs. RR12 downtown is just over 1 km downstream from Blue Hole, where phosphorus has never been found above detection limits. This segment of the creek is at a low elevation very close to the Blanco River and has the greatest potential for groundwater interactions to alter chemistry. The surface area contributing flow between Blue Hole and downtown is a mix of agriculture in the upper portions, residential and commercial along the creek channel, and a cemetery on the eastern edge. Such a pattern of exceedances could be caused by natural decomposition of minerals and vegetation, erosion and sedimentation, failing OSSF systems, direct input by animals/wildlife, and other nonpoint source pollutants. It could also indicate untreated or poorly treated wastes, though elevated phosphorus is more common with point discharges from wastewater treatment, whereas nitrogen is more often cited as a concern from failing septic systems. Another potential source is the excessive application of fertilizer.

Nitrogen is present at low concentrations at all sites under ambient conditions and is actually highest in spring flows out of Jacob's Well with a median concentration of 0.47 mg/L. Nitrogen levels at Jacob's Well track closely with the target maximum load of 0.5 mg/L (Figure 6.4). Exceedances of this level occur at higher flows and at all sites except the confluence, indicating a nonpoint source that washes nitrogen into the creek above downtown Wimberley along with high flows. High nitrate concentrations may not be strictly from natural sources and can indicate contamination from fertilizers, manure, or sewage. The fact that the confluence has the lowest maximum level recorded, only 1.13 mg/L, means that biological processes in the stream may be assimilating excess nitrogen before reaching the confluence, which could potentially explain algal blooms observed in upper portions of the perennial Cypress Creek during dry periods. The 0.1 mg/L target is always exceeded at 0 to 20% flows (above about 25 cfs), suggesting that surface runoff consistently contains higher concentrations. Below that flow level, all sites exceed this target at various times along the full range of flows, although the confluence has the lowest number of exceedances.

the stream or on the surface of contributing areas as likely nonpoint sources, particularly in the area above RR12 downtown. Different forms of nitrogen have been monitored at different times throughout the period of record, and these different forms can indicate different pollution sources. From November 2004 to present, reported values for nitrogen are for nitrate-N only, often associated with excess fertilizer use, as opposed to ammonia which tends to indicate organic wastes. However ammonia from organic waste can also be converted by instream processes into nitrate, a reaction which also depletes oxygen in the water. Further examination of the relative abundances of specific forms of nitrogen found in the creek will help to pinpoint exactly the contributing sources. Phosphorus is generally not above detection limits even when nitrogen is elevated, and phosphorus exceedances are often associated with relatively low levels of nitrogen. Furthermore, P exceedances are correlated with elevated TSS only in a few instances and often occur at very low TSS concentrations, a fact that tends to rule out sediment inflow as a source of natural phosphorus. In a phosphorus-limited stream such as the Cypress Creek, it is possible that excess phosphorus from fertilizer application could be more quickly assimilated than nitrogen, resulting in elevated nitrogen only. However further study is needed to help pinpoint specific sources of excess phosphorus when nitrogen is not also elevated, near RR12 downtown in particular.

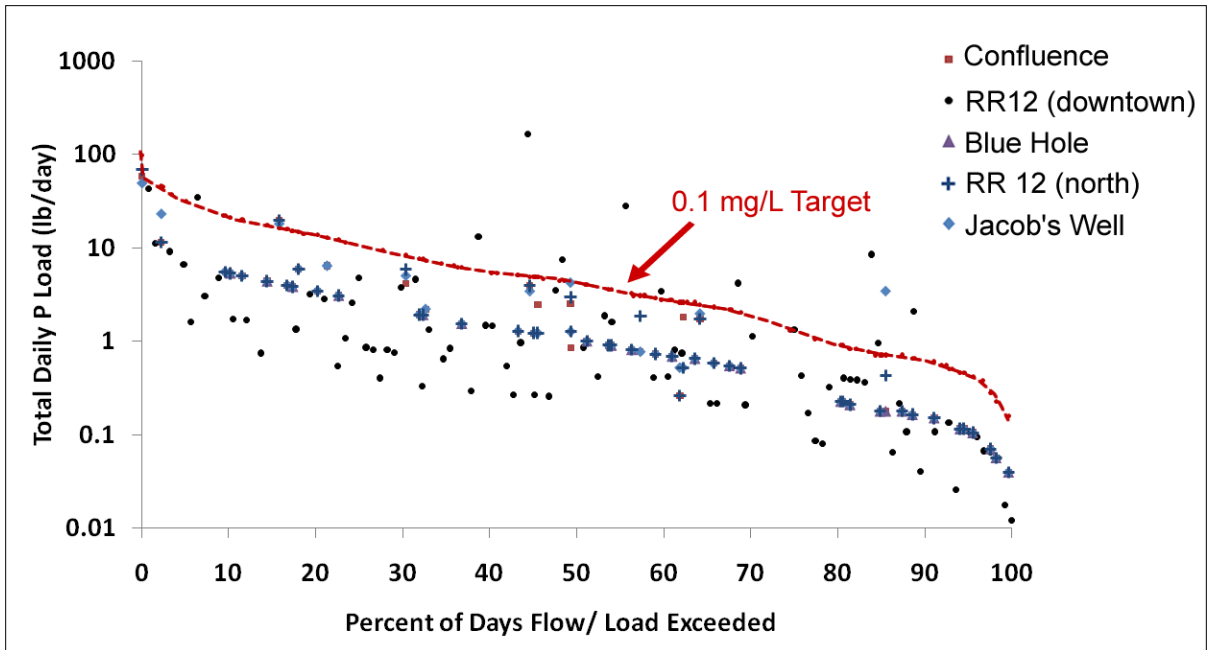
Figure 6.3. Load duration curve of total phosphorus at five sites along Cypress Creek.

The red dashed line represents phosphorus loads at a target maximum concentration of 0.1 mg/L, and dots represent loads calculated for observed conditions.

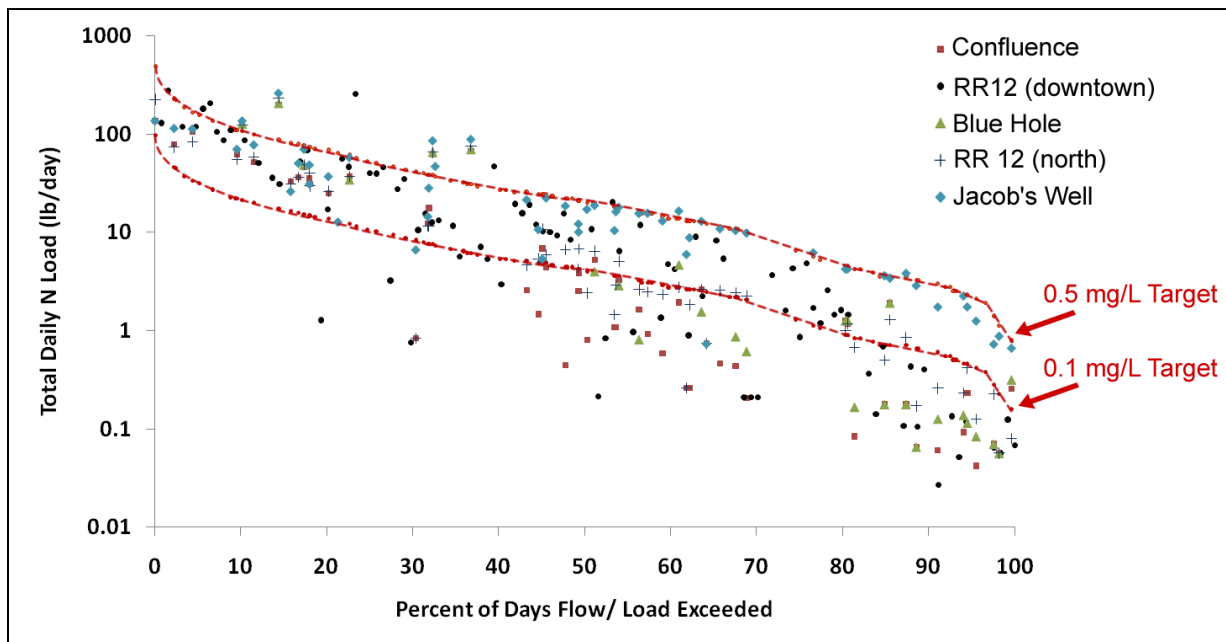
Figure 6.4. Load duration curve of nitrogen at five sites along Cypress Creek.

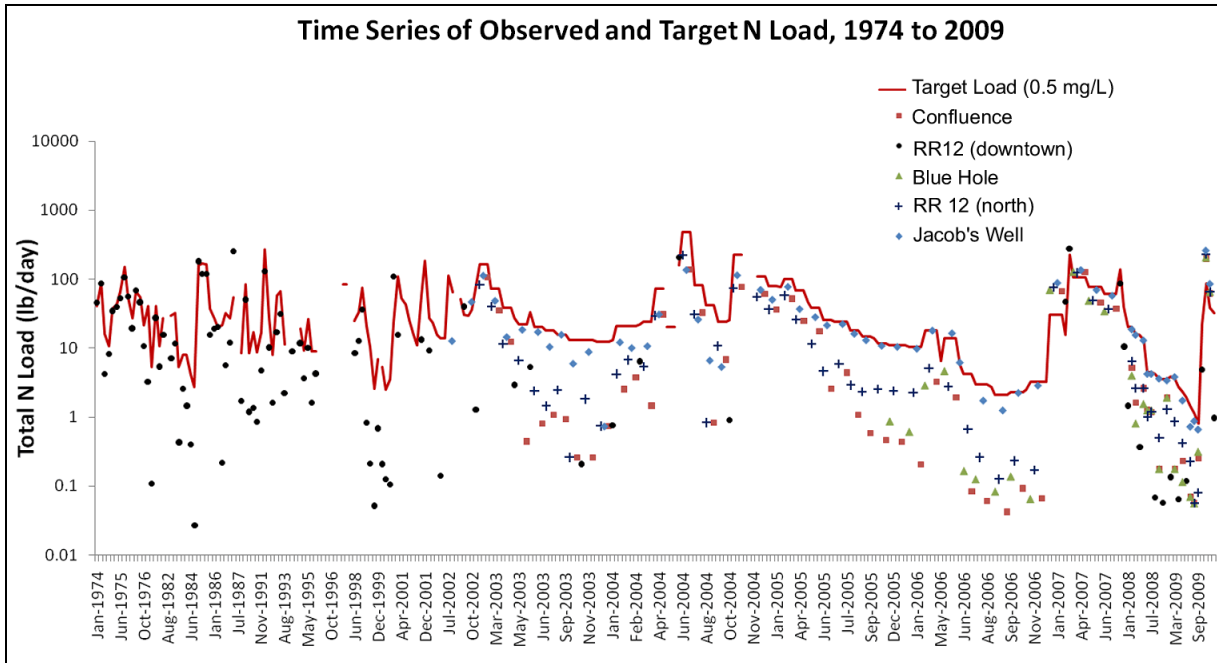
Figure 6.5. Time series of observed and target nitrogen load for five sites along Cypress Creek.

Samples are taken monthly (CRP sites) or quarterly (TCEQ site). The red line indicates target loads calculated based on available flow estimates and 0.5 mg/L concentration. Points above this line represent exceedances of the target load.

January through April 2007 (Figure 6.5). This evidence supports a nonpoint source of nitrogen in the contributing area, such as fertilizer or animal waste that builds up on the surface during dry periods and is washed in when rainfall produces surface runoff. This pattern is in contrast to the pattern of phosphorus loads, which points instead to a loading mechanism that acts at moderate flow levels.

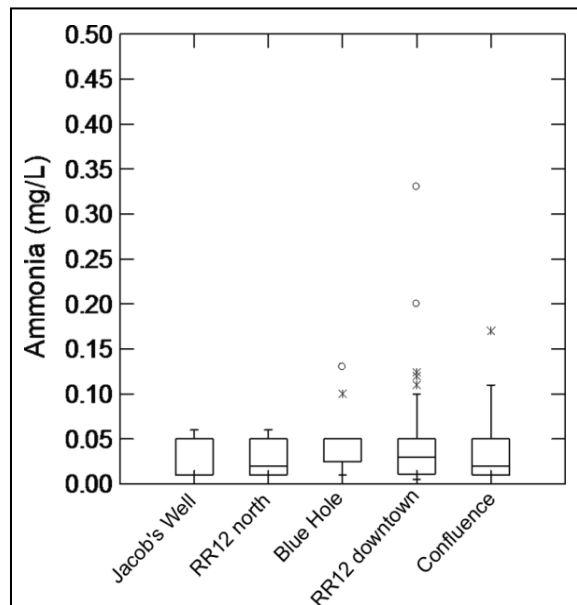
Figure 6.6. Box-and-whisker plot showing the variability of ammonia (mg/L) measured at five sites along the Cypress Creek.

Lines through the center of boxes represent the median value, bottom and top of boxes represent the 25th and 75th percentiles, respectively, and whiskers show the 5th and 9th percentiles. Dots are outlying values.

Generally ammonia levels in the creek are relatively low, often registering below detection limits. However elevated levels have been measured at various times, and a maximum of 0.92 mg/L was recorded at RR12 downtown (Figure 6.6). Lethal ammonia concentrations for a variety of fish species range from 0.2 to 2.0 mg/L and chronic ammonia toxicity is particularly harmful to juveniles (US-EPA, 2009). The load duration curve for ammonia indicates that exceedances occur across all flow levels at RR12 downtown, but the magnitude of exceedances is much higher at lower flows (Figure 6.7). Many of the highest magnitude exceedances happened at RR12 downtown between 1998 and 2000, while later problems are less severe. No exceedances are seen at the two uppermost sites, where the maximum levels recorded are only 0.06 mg/L. Exceedances at Blue Hole and the confluence sites occur at medium to low flows, again with the magnitude of exceedance increasing at low flows. A product of microbiological activity, ammonia in freshwater often indicates a failing septic system or source of untreated waste. Because the highest exceedances occur at the lowest flows, this points to a local source of untreated waste, either failing septic systems or wildlife, bird, or pet waste deposited directly into the stream and/or riparian area. However the fact that the highest magnitude exceedances have not been seen in the last 10 years suggests that some previous sources may have been mitigated since that time. Exceedances at higher flows result from untreated waste in upland areas washing into the stream during rain events.

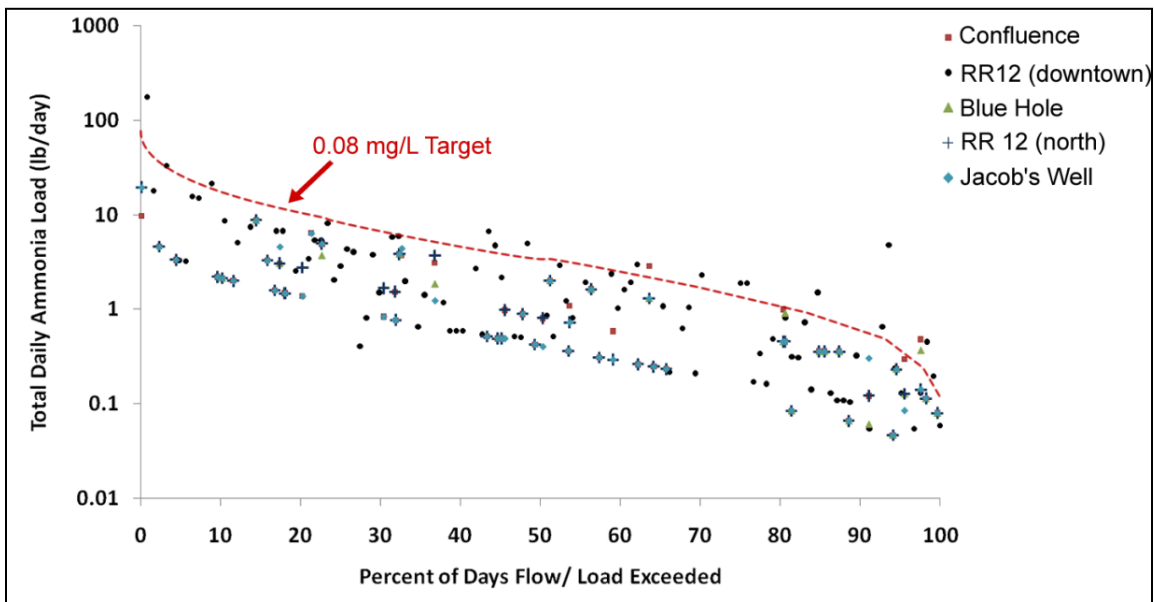
Figure 6.7. Load duration curve of ammonia at five sites along Cypress Creek.

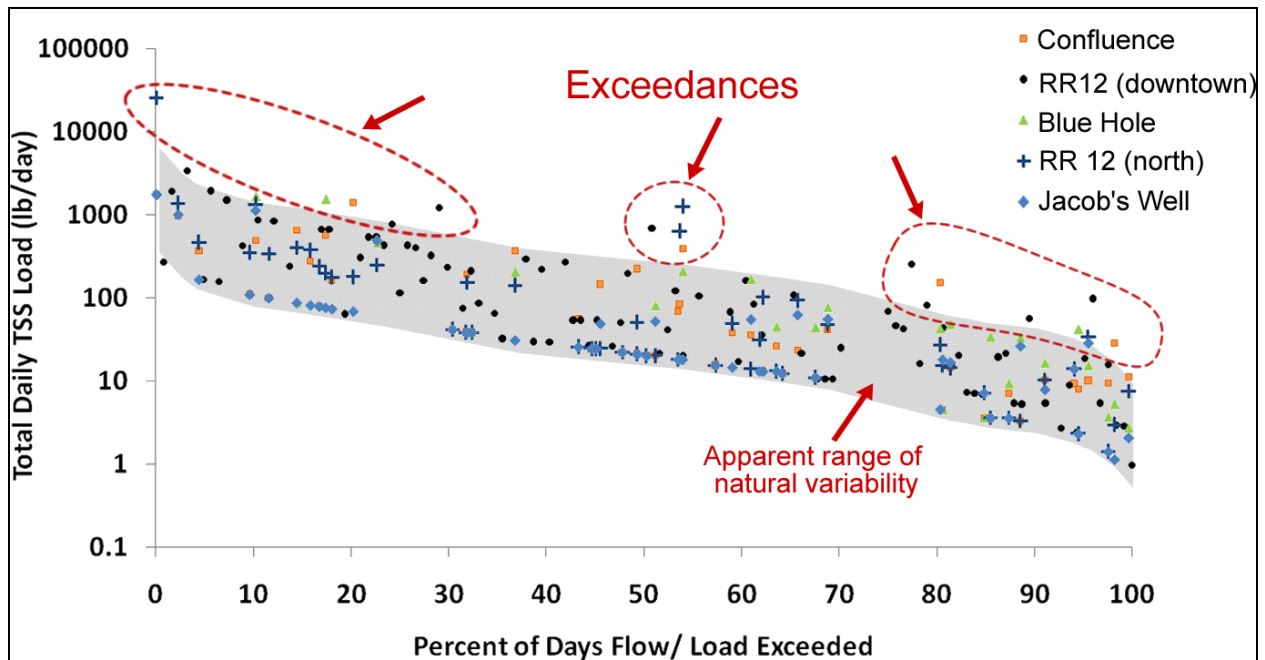
Figure 6.8. Load duration curve of total suspended solids (sediment) at five sites along Cypress Creek.

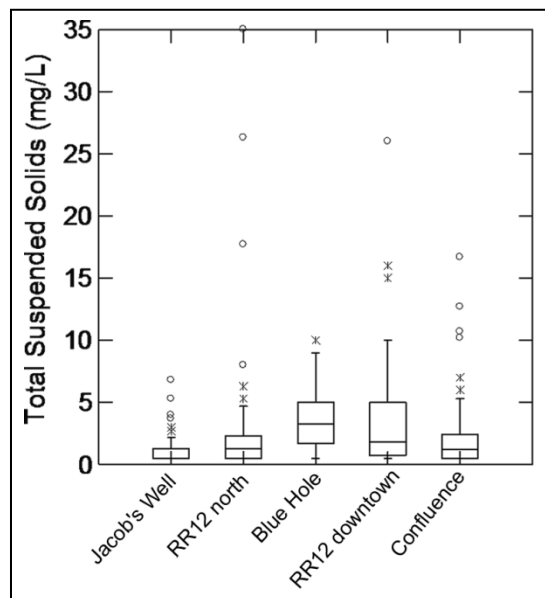
Figure 6.9. Box-and-whisker plot showing the variability of total suspended solids (mg/L) measured at five sites along the Cypress Creek.

Lines through the center of boxes represent the median value, bottom and top of boxes represent the 25th and 75th percentiles, respectively, and whiskers show the 5th and 9th percentiles. Dots are outlying values.

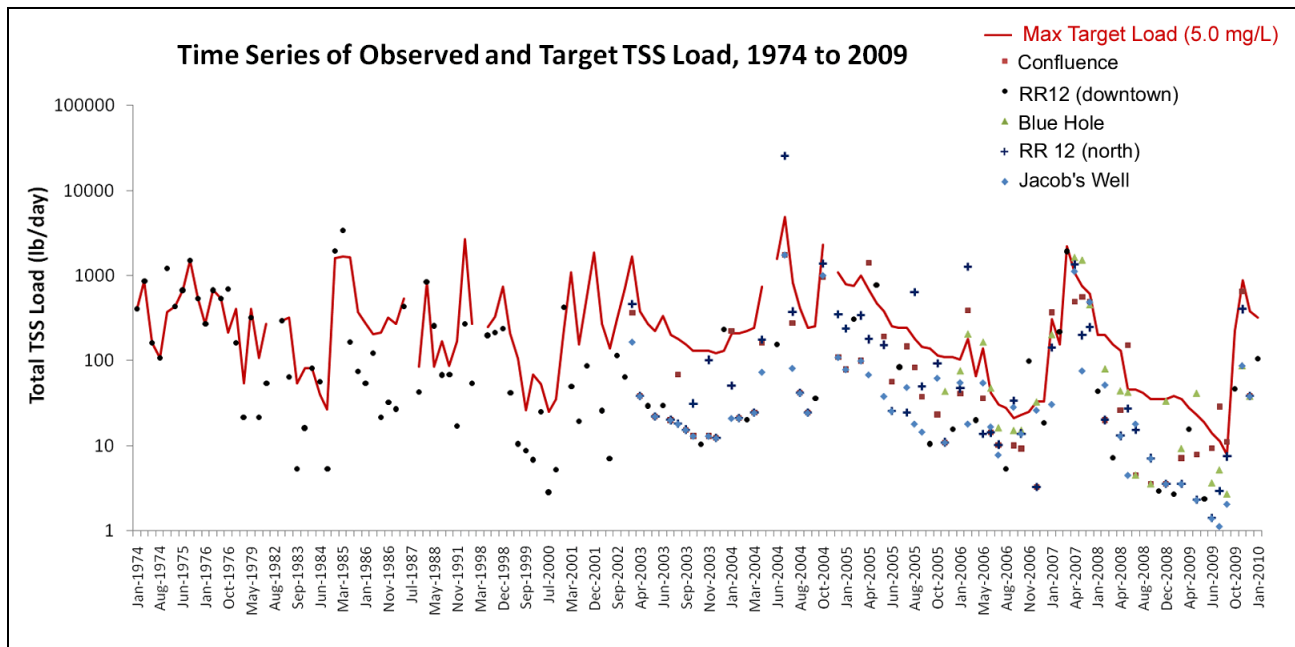
Figure 6.10. Time series of observed and target maximum sediment load for five sites along Cypress Creek.

Samples are taken monthly (CRP sites) or quarterly (TCEQ site). The red line indicates target loads calculated based on available flow estimates and 5.0 mg/L concentration. Points above this line represent exceedances of the target load.

A time series of target maximum (5.0 mg/L) and observed sediment concentrations reveals that there are a cluster of exceedances that occurred from spring 2005 through fall 2006 (Figure 6.10). A major roadway, Winters Mill Parkway, was under construction from October 2005 to July 2007 in the southeastern portion of the watershed. Some of the highest relative exceedances in the spring of 2006 may be associated with the construction of this road, although RR12 downtown and the confluence both had exceedances in the spring of 2005 before work started. Instream dredging operations were documented in 2005. In addition exceedances occur at all sites during this period, including those above the influence of bypass construction. Other construction activities along RR12 and Jacob's Well Rd. could contribute excess sediment to the creek as well, if proper stormflow mitigation measures are not employed.

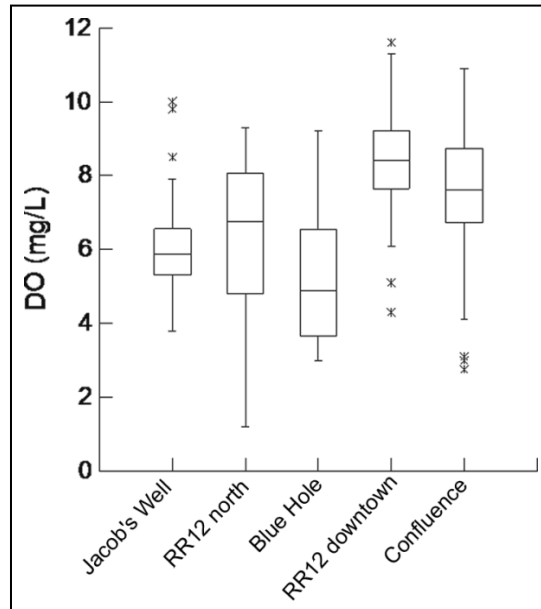
Figure 6.11. Box-and-whisker plot of dissolved oxygen (mg/L) measured at five sites along the Cypress Creek.

Lines through the center of boxes represent the median value, bottom and top of boxes represent the 25th and 75th percentiles, respectively, and whiskers show the 5th and 9th percentiles. Dots are outlying values.

Dissolved oxygen varies considerably from site to site (Figure 6.11), with springflow coming out of Jacob's Well at a lower DO concentration (median=5.88 mg/L; n=62), rising slightly as it travels to the upper RR12 crossing (median=6.76 mg/L; n=60), then dropping sharply again at Blue Hole (median = 4.90 mg/L; n=27). By the lower RR12 crossing through downtown Wimberley, dissolved oxygen is generally excellent, with 98% of samples taken equaling or exceeding 6.0 mg/L (median=8.40 mg/L; n=132). Dissolved oxygen then drops slightly between downtown and the confluence (median=7.6; n=63). At the confluence, only 84% of samples exceed (are below) the target of 6.0 mg/L for exceptional aquatic life use. DO saturation levels at Jacob's Well are relatively consistent, with concentrations between 5.0 and 7.0 mg/L, and provide a steady flow of cold water into the creek. As the water travels downstream, it picks up some oxygen through mixing with air and biological processes along its course. The RR12 north site seems to be susceptible to lower flows and higher temperatures, with a wider range of DO values recorded that are correlated with temperature. Shortly downstream, flow is reduced and the creek forms a large, relatively deep swimming hole at Blue Hole. There is anecdotal evidence of numerous small springs and seeps contributing cold groundwater into the creek at this point. DO drops dramatically, and only exceeds 6.0 mg/L in 37% of samples. It is likely that this combination of decreasing flow velocity and groundwater input acts to reduce DO levels here. Downstream of Blue Hole, the stream gains oxygen and by the RR12 downtown site it is consistently high with only two values below 6.0 recorded here, in August 1994 and July 1996. The drop in DO between downtown and the confluence could be due to increased water temperature or to increasing microbial activity from an excess of organic material.

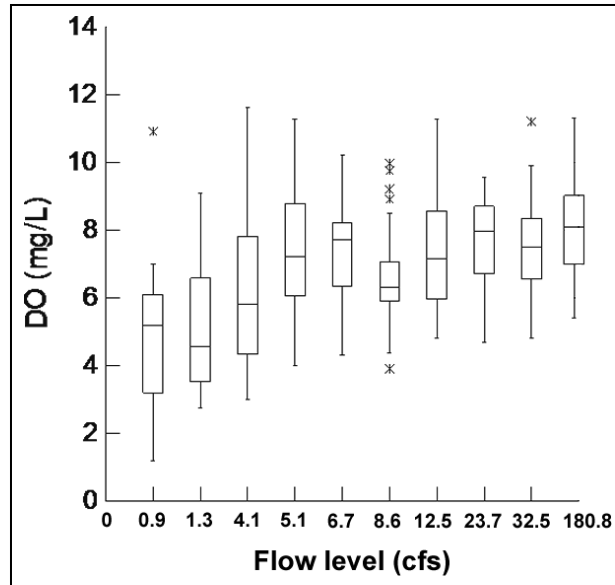
Figure 6.12. DO concentrations by flow level.

Flow levels (given in cubic feet per second) correspond to the 10th, 20th, 30th, etc. percentile of flows estimated at the Cypress Creek confluence, 2000-2009. In this chart, a flow level of 0.9 reflects DO concentrations measured when flow is ≤ 0.9 cfs, 1.3 indicates flow from 0.91 to 1.3 cfs, etc.

More evidence that flow plays a primary role in dissolved oxygen concentrations is seen by examining plots of dissolved oxygen across a range of flow levels. 10th, 20th, 30th, etc. percentiles were calculated for flows estimated at the confluence from 2000 to 2009 and DO observations plotted at each level (Figure 6.12). For all sites, a flow level between 1.31 and 4.1 cfs appears to be sufficient to sustain DO levels above 4.0 mg/L at least 75% of the time. 6.0 mg/L is a minimum 24 hour standard for maintaining adequate conditions for aquatic ecosystems. Between 4.11 and 5.1 cfs, DO exceeds 6.0 mg/L at least 75% of the time, which is a target level for maintaining a healthy aquatic community.

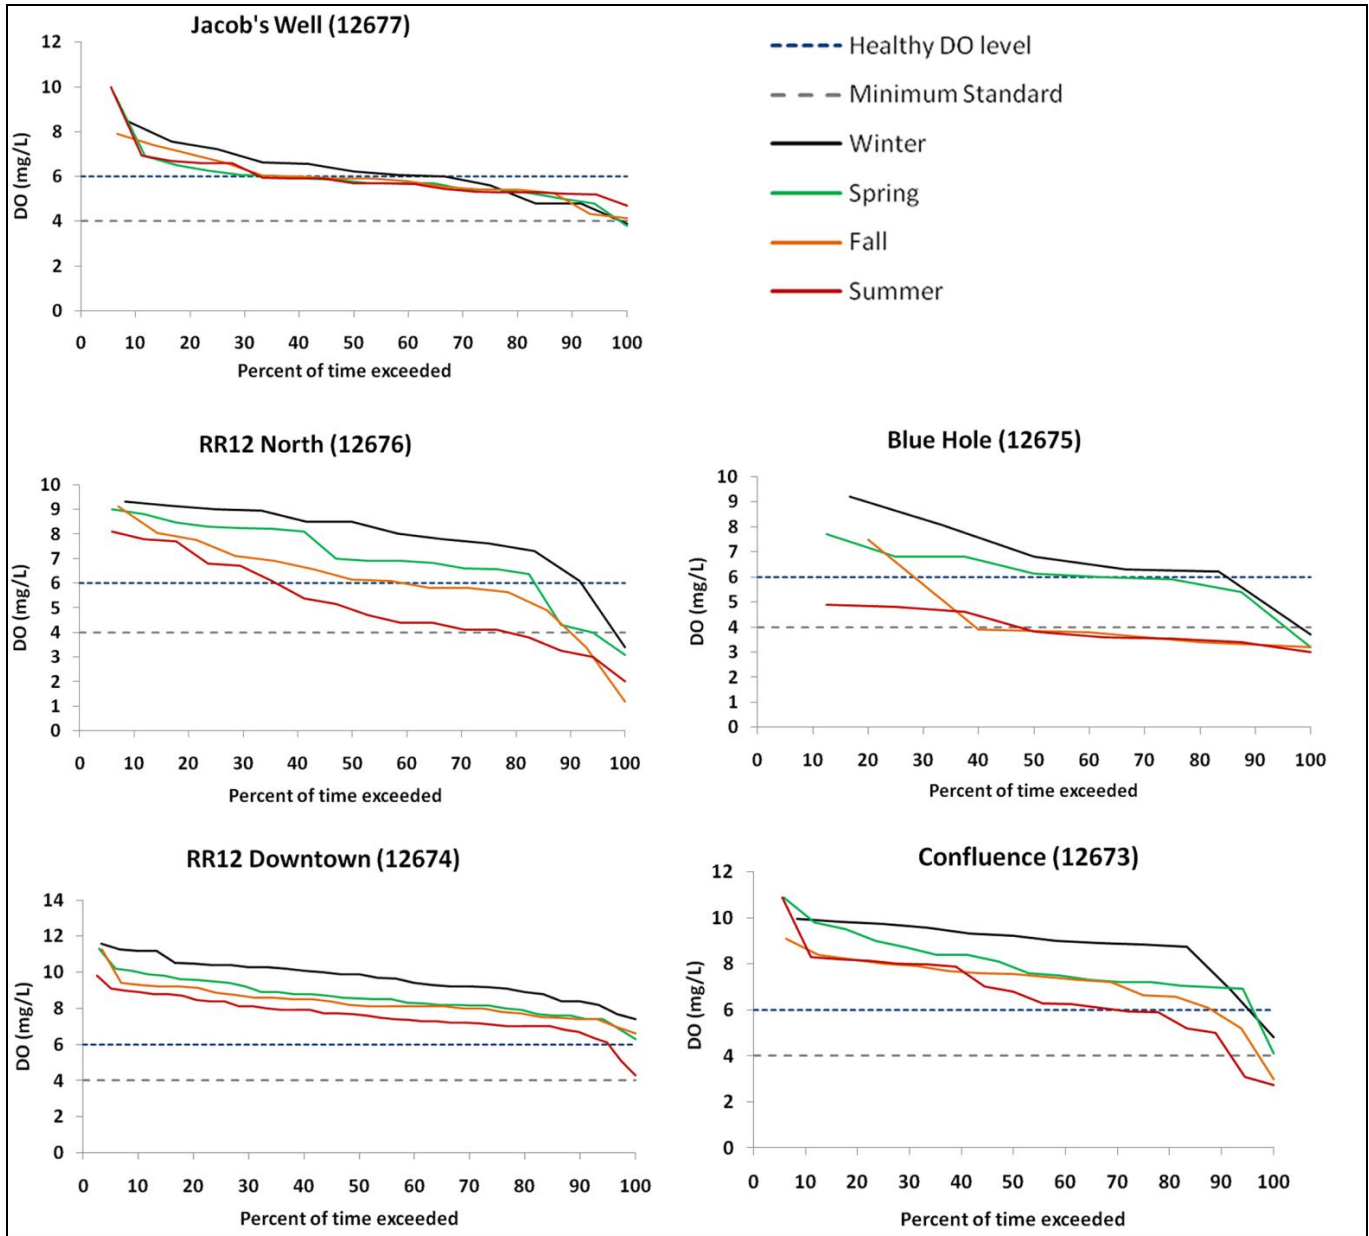
Figure 6.13. Percent exceedance curves for dissolved oxygen by season.

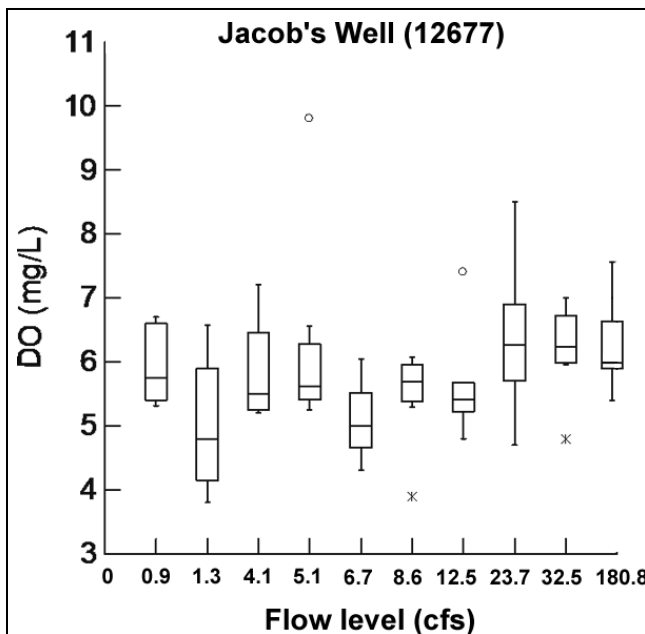
Flow levels (given in cubic feet per second) correspond to the 10th, 20th, 30th, etc. percentile of flows estimated at the Cypress Creek confluence, 2000-2009. In this chart, a flow level of 0.9 reflects DO concentrations measured when flow is ≤ 0.9 cfs, 1.3 indicates flow from 0.91 to 1.3 cfs, etc. At this site DO is more affected by the amount of groundwater flow coming out of Jacob's Well Spring than by streamflow at the surface.

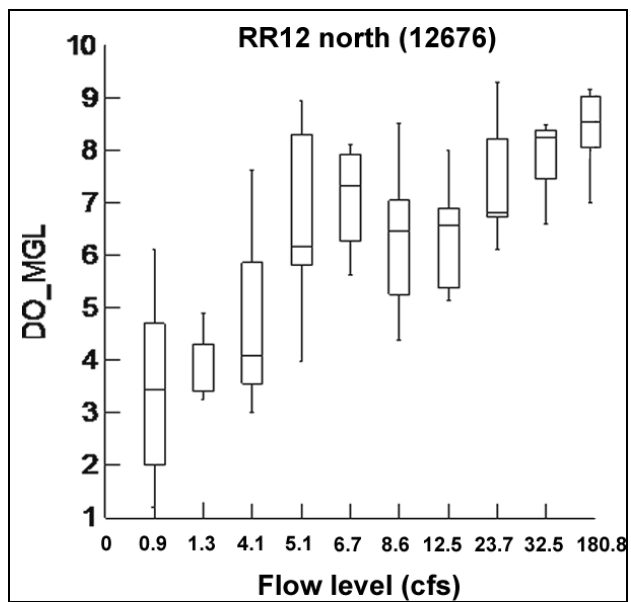
Flow levels (given in cubic feet per second) correspond to the 10th, 20th, 30th, etc. percentile of flows estimated at the Cypress Creek confluence, 2000-2009. In this chart, a flow level of 0.9 reflects DO concentrations measured when flow is ≤ 0.9 cfs, 1.3 indicates flow from 0.91 to 1.3 cfs, etc. At this site the median DO concentration increases significantly at the 4.11 - 5.1 cfs flow level.

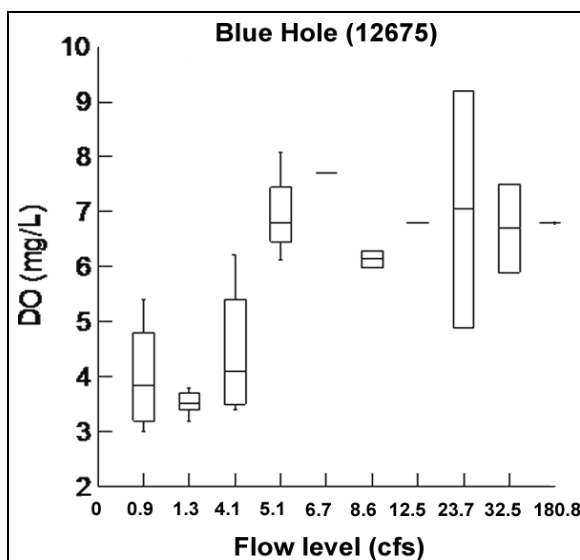
Flow levels (given in cubic feet per second) correspond to the 10th, 20th, 30th, etc. percentile of flows estimated at the Cypress Creek confluence, 2000-2009. In this chart, a flow level of 0.9 reflects DO concentrations measured when flow is ≤ 0.9 cfs, 1.3 indicates flow from 0.91 to 1.3 cfs, etc. At this site the median DO concentration also increases significantly at the 4.11 - 5.1 cfs flow level.

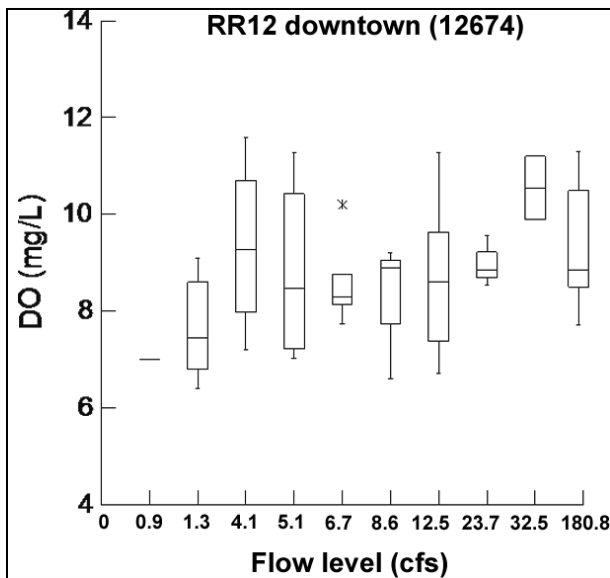
Flow levels (given in cubic feet per second) correspond to the 10th, 20th, 30th, etc. percentile of flows estimated at the Cypress Creek confluence, 2000-2009. In this chart, a flow level of 0.9 reflects DO concentrations measured when flow is ≤ 0.9 cfs, 1.3 indicates flow from 0.91 to 1.3 cfs, etc. At this site, DO concentrations tend to increase at the 1.31-4.1 cfs flow level.

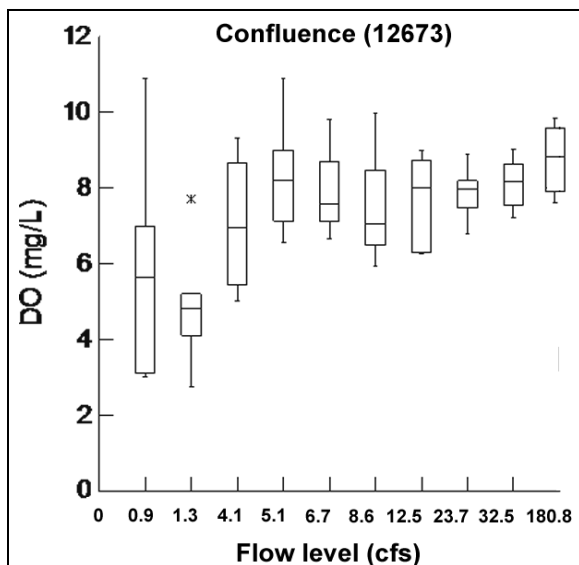
Flow levels (given in cubic feet per second) correspond to the 10th, 20th, 30th, etc. percentile of flows estimated at the Cypress Creek confluence, 2000-2009. In this chart, a flow level of 0.9 reflects DO concentrations measured when flow is ≤ 0.9 cfs, 1.3 indicates flow from 0.91 to 1.3 cfs, etc. At this site DO concentrations improve markedly above the 1.31 - 4.1 cfs flow level, and always exceed 6.0 mg/L at 5.1 cfs and above.

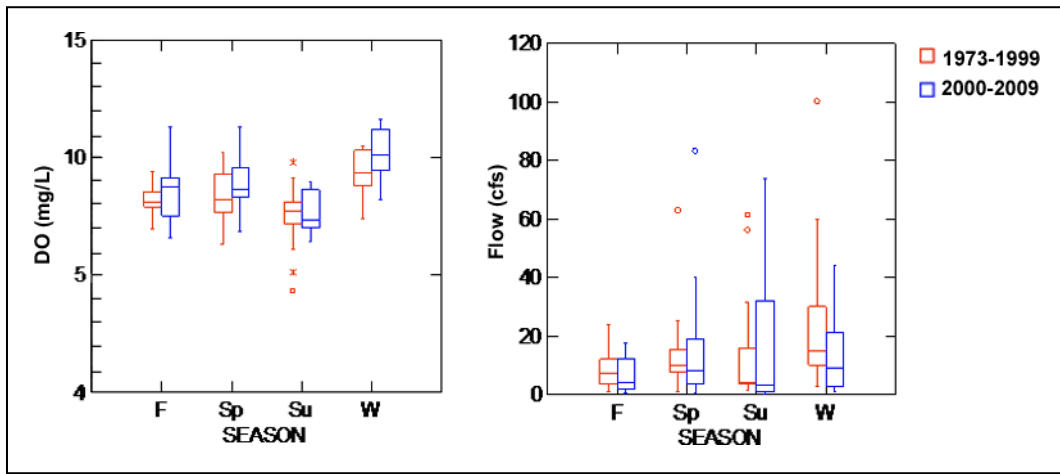
Figure 6.19. Box-and-whisker plots of DO and instantaneous flow (1973-1999 and 2000-2009)

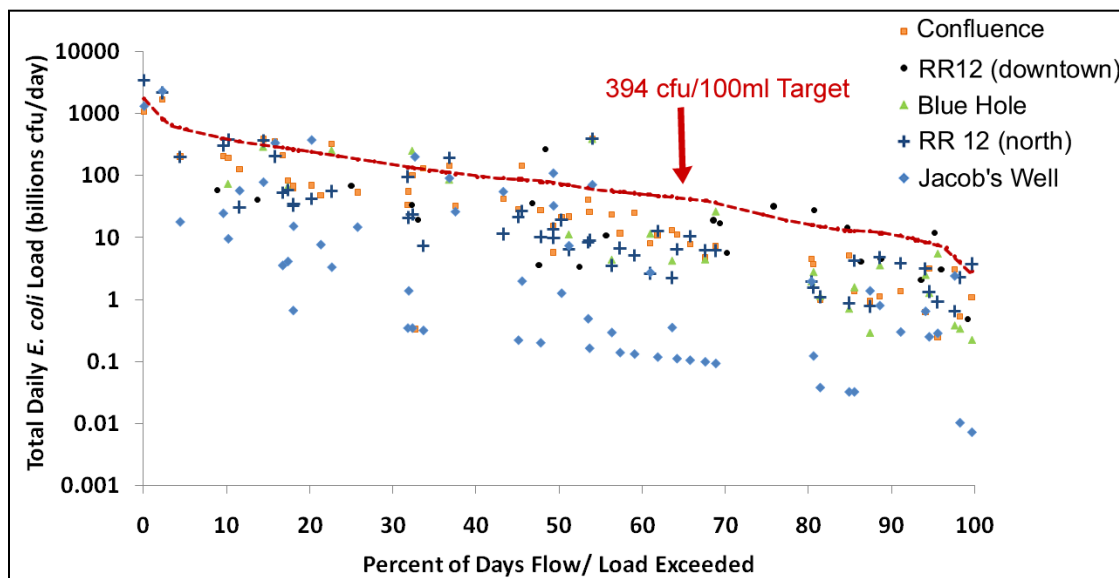
Figure 6.21. Load duration curve of *E. coli* at five sites along Cypress Creek.

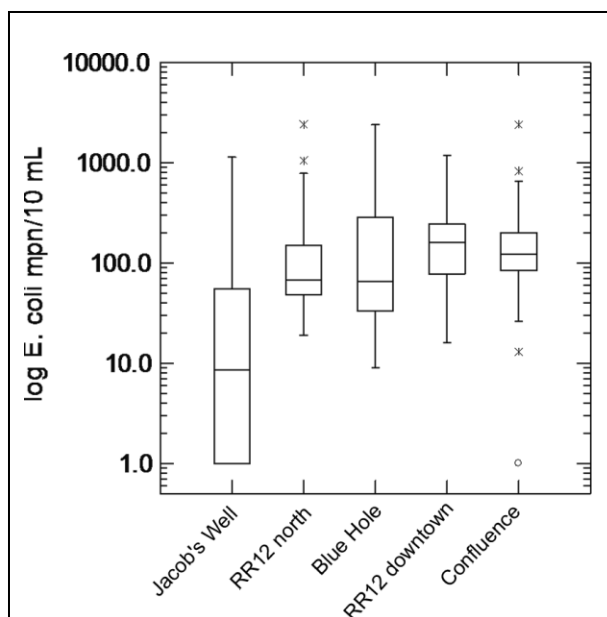
Figure 6.22. Box-and-whisker plot of *E. coli* (cfu/100 ml) measured at five sites along the Cypress Creek.

Lines through the center of boxes represent the median value, bottom and top of boxes represent the 25th and 75th percentiles, respectively, and whiskers show the 5th and 9th percentiles. Dots are outlying values.

At lower flows (below about 2 cfs), *E. coli* exceedances occur primarily at RR12 downtown. Because there would be very little surface flow during these dry periods, *E. coli* must be contributed by shallow subsurface flow from septic systems in the local area or pet/animal waste placed directly in the stream and riparian area. Two of the four low-flow *E. coli* exceedances at RR12 downtown are associated with elevated ammonia; however many times the two are not closely correlated. Higher *E. coli* values are correlated with elevated TSS levels at all sites except at Jacob's Well, which tends to have the lowest bacteria concentrations due to the influence of spring flow (Figure 6.22), but also has the greatest variability of observed concentrations.

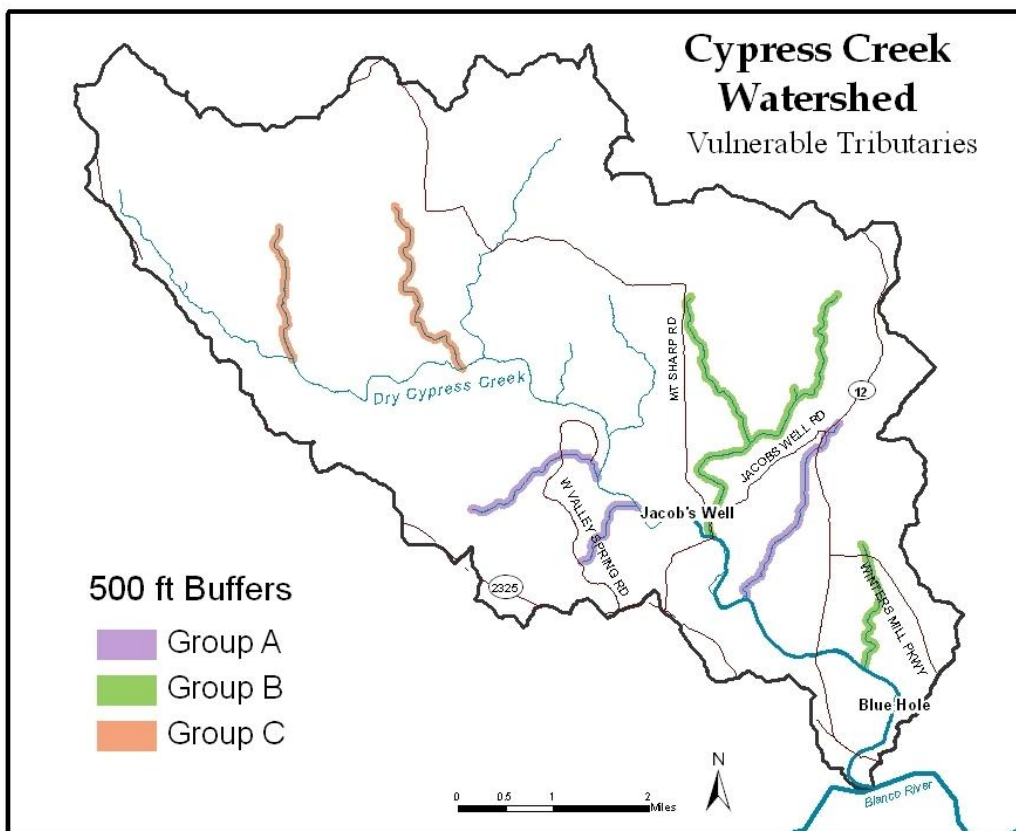
Figure 7.1. Vulnerable areas recommended for BMPs.

Group A tributaries drain areas where high-intensity residential development is already in place or platted for the near future. One of these (Hog Creek) also drains much of the area around RR12, where new residential and commercial development is likely to occur. Along these tributaries, riparian buffers and other BMPs will be very important for new construction. Education of existing riparian landowners regarding riparian management and restoration of disturbed buffers is recommended.

Much of the focus on pollution sources and best management practices (BMPs) has been on impacts to the perennial Cypress Creek itself. However management of pollution loads from upland areas and along major tributaries will also help to maintain water quality in the main creek. Based on analysis of water quality, potential pollutant loadings, land cover, and current and future patterns of development, **three groups of tributaries are recommended for priority attention to buffers and other BMPs** that will help to keep the creek clean and clear (Figure 7.1). Group A is considered priority due to current and near future developments, group B due to potential future development, and group C due to high potential runoff and sediment yields.

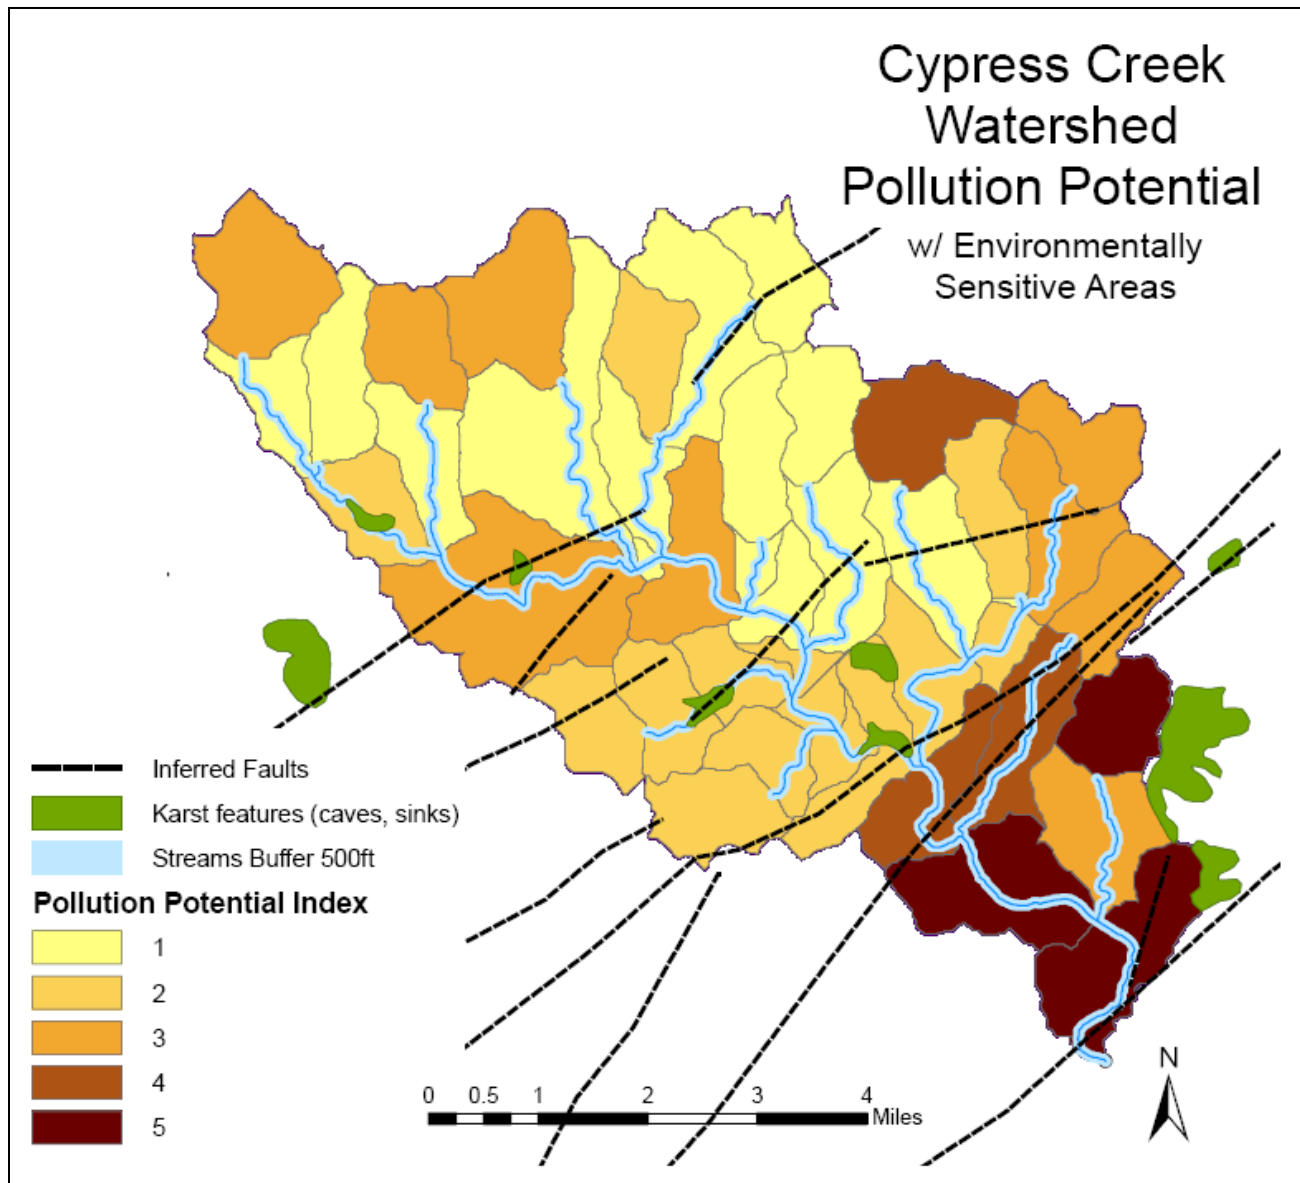
Figure 7.2. Composite subwatershed map of potential pollutants.

An overlay of potential pollutant loadings with karst features, faults, and riparian areas reveals that the areas of highest potential loading often have additional environmental sensitivities that must be considered when managing new developments (Figure 7.2). Faults and caves in the upper parts of the watershed are likely places of localized aquifer recharge. There is anecdotal evidence that these features can act as major sinks during rainfall events. Faults and karst features in the mid to lower portions of the watershed are more likely to produce springs and seeps where subsurface flow is redirected back to surface channels, particularly during wet periods when the water table in the shallow aquifer rises.

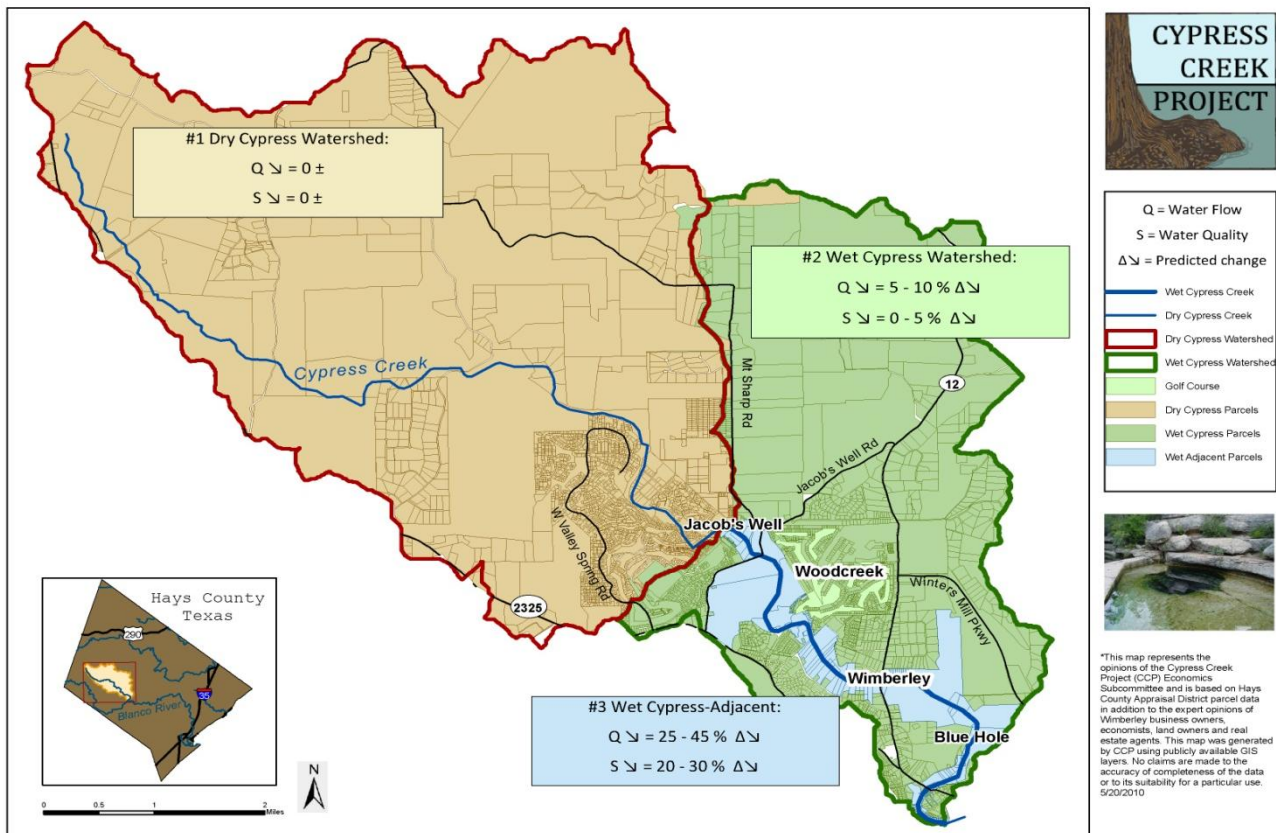
Figure 7.3. Predicted economic effects of water quality degradation.

In Figure 7.3, 'Q' represents Water Flow, while 'S' represents the water quality of the creek. Using Hays County Appraisal data and the percentages determined by the Subcommittee, predicted losses resulting from the degradation of the creek in quantity and quality were determined. It was found that in the upper dry segment of Cypress Creek, market land/home values would not be affected by a decrease in water flows or quality because land values in that part of the watershed were not based on their proximity to the flowing creek. The Economic Subcommittee data suggest the greatest economic effect of a degraded creek would be to the wet/adjacent portion of the watershed where decreased flows would cause a 25-45% drop in market values while decreased water quality would result in a 20-30% decline in market values. This would potentially reduce the market values of this portion (wet/adjacent) of the watershed by nearly half.

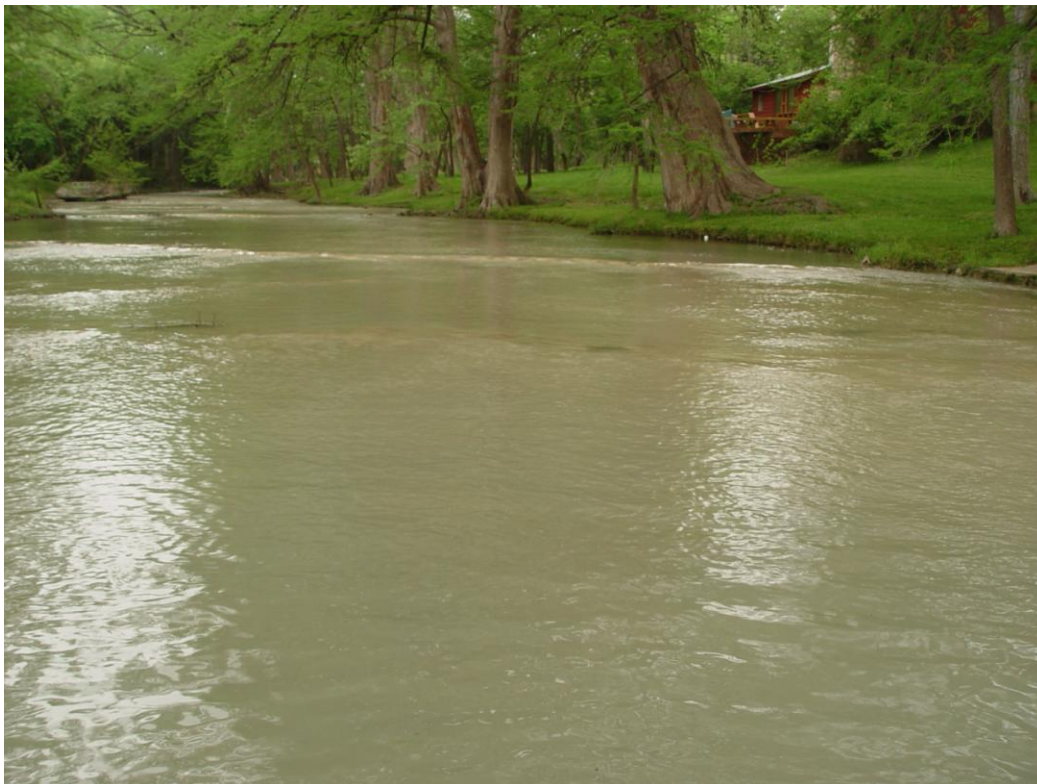
Figure 7.4. High sediment flow in the creek, 2005. Photo by Jason Pinchback.

Elevated sediment loads are observed during low, moderate, and high flow conditions. The primary area where sediment is chronically problematic is the stretch of creek from RR12 north to the confluence with the Blanco River. There are two major tributaries that join the main creek from the north between Jacob's Well and RR12 north. These two creeks may carry sediment from high-slope areas in the north and contribute to higher sediment levels at RR12 north. The largest increase in median sediment concentrations occurs between RR12 north and Blue Hole. There is one major tributary that joins the main creek between these two sites that may contribute large volumes of sediment during high flows, and Blue Hole being a prime recreation area may contribute to sediment in the creek during low flows. The construction of Winters Mill Parkway starting in 2005 coincides with observed elevated readings in the 2005 to 2007 period. As observed in the 2005 data, instream dredging is also impacting the stream (Figure 7.4). It is important to consider managing sediment throughout the entire watershed and not just in the riparian areas.

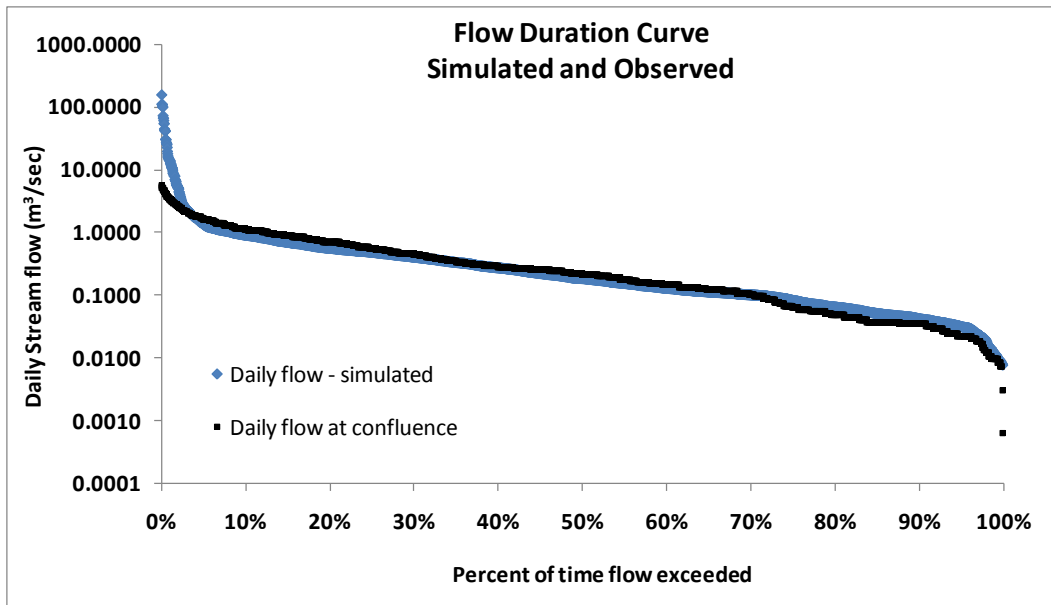
Figure B.1. Simulated and Observed Flow Duration Curves for the Cypress Creek watershed. Daily flows (m^3/sec) were simulated using the SWAT2000 hydrologic model.
