Cypress Creek Project Watershed Characterization Report

CYPRESS CREEK WATERSHED PROTECTION PLAN

Characterization Report

**The River Systems Institute
Texas State University-San Marcos**

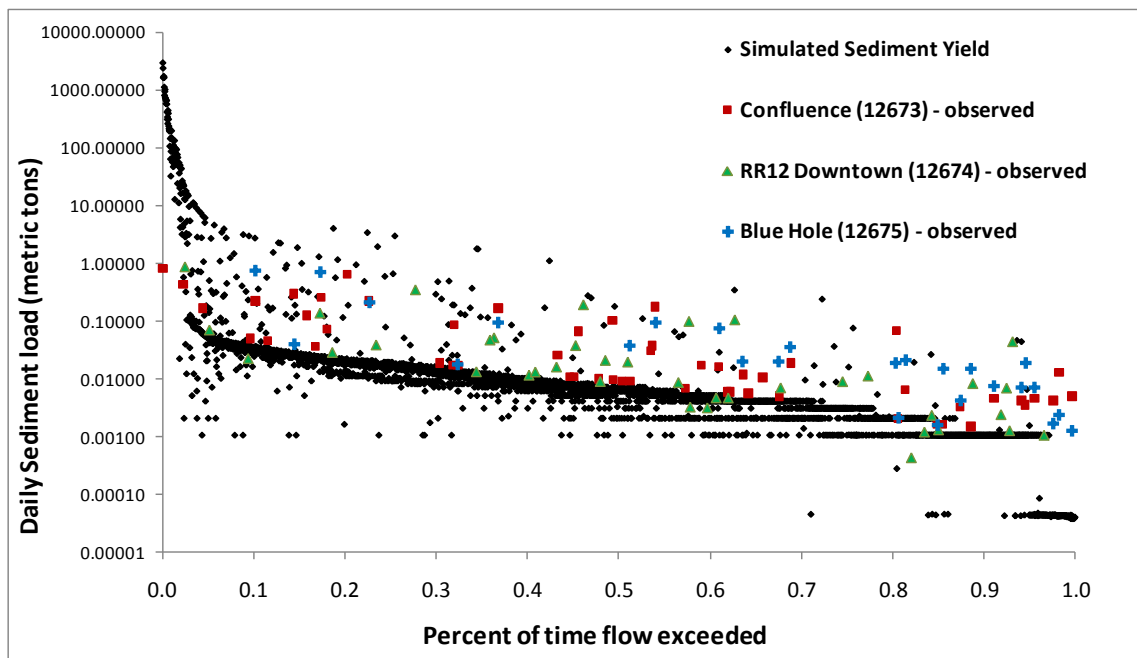
Figure B.2. Simulated and Observed Load Duration Curves for sediment (metric tons). Overall the simulated sediment loads are within the same range as observed, although at the lowest flows the model tends to underestimate sediment loads.

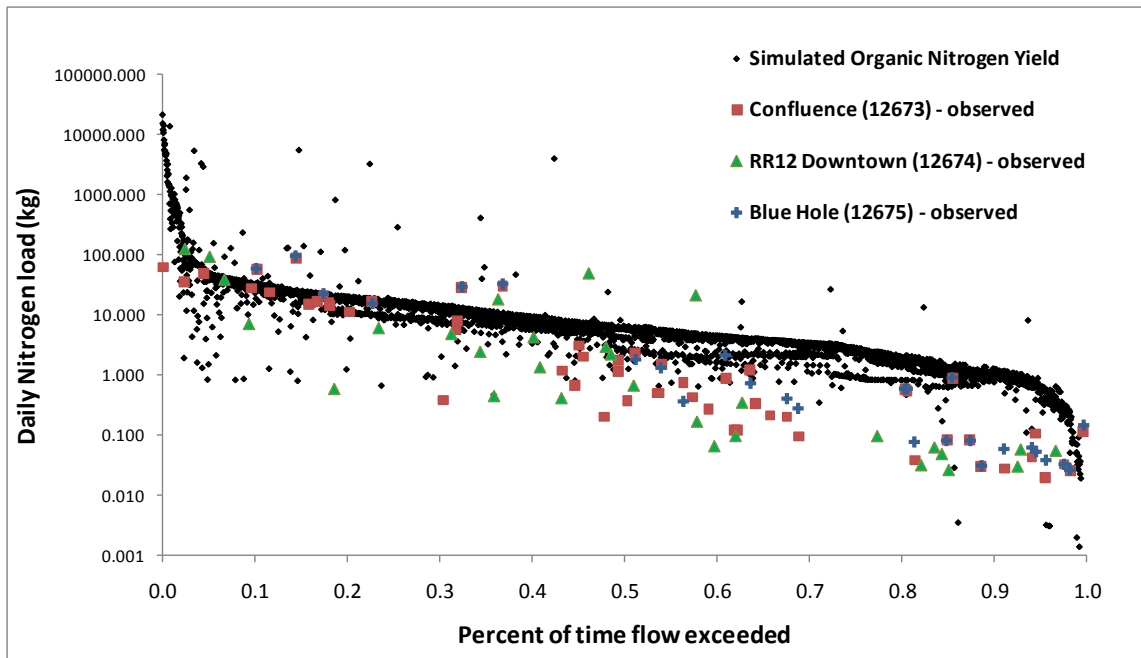
Figure B.3. Simulated and Observed Load Duration Curves for organic nitrogen (kg). Overall the simulated nitrogen loads are within the same range as observed, although at the lowest flows the model may overestimate nitrogen.
